**FINAL REPORT**  
March 14, 2005

## The Conservation Of Plaster Ornament Library Of Parliament, Ottawa

Completed between November 2004 and February 2005  
By  
**Historic Plaster Conservation Services Limited**

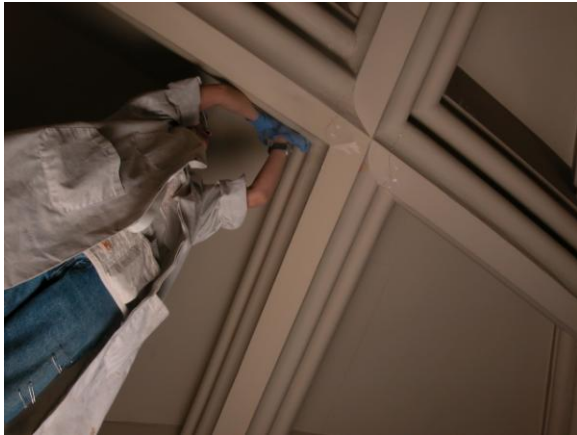
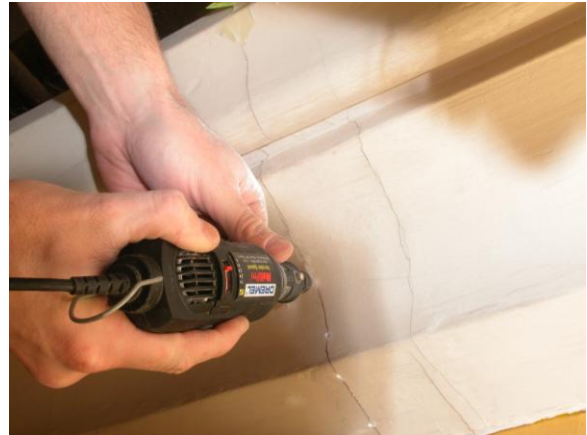
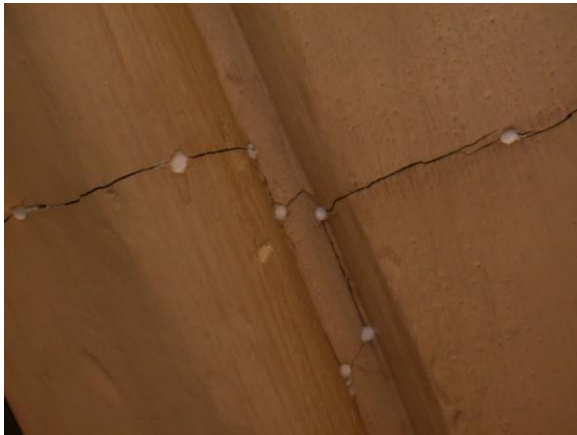
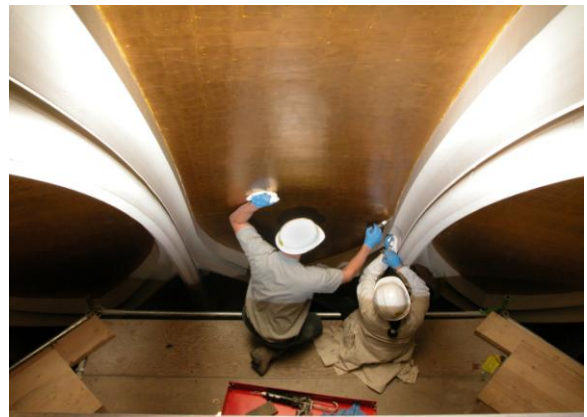
The hollow cast plaster ribs that rise from the corbels at the base of the drum were inspected carefully and found to be in substantially good condition. The method of construction was thin walled reinforced casting in two sided molds. The finished ribs had been raised into location and tied in place with malleable fence wire. Finish plastering of the wall behind them provided a lock so that the ribs did not move. Ribs running counter clockwise (imagining the building in plan) were installed first and in longer sections. Then ribs running clockwise were put in place in shorter pieces. The intersections between crossing ribs was an area requiring conservation.

Fine holes were drilled at about  $\frac{3}{4}$ " apart along any cracks found. The cracks were rinsed out thoroughly with a pre-wetting solution of methyl hydrate, and then reinjected with a thickened HPCS adhesive. Many thousands of holes were drilled and injected across the entire rib system.

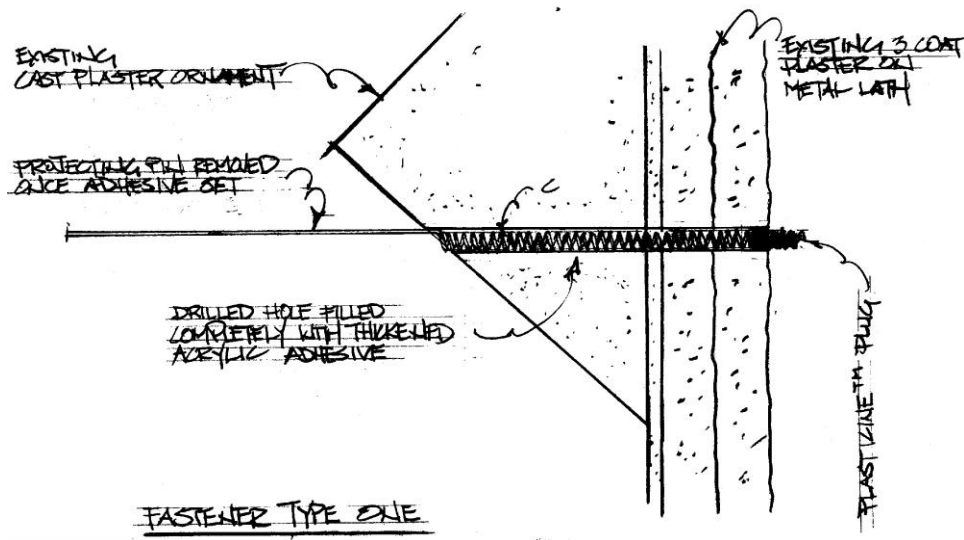
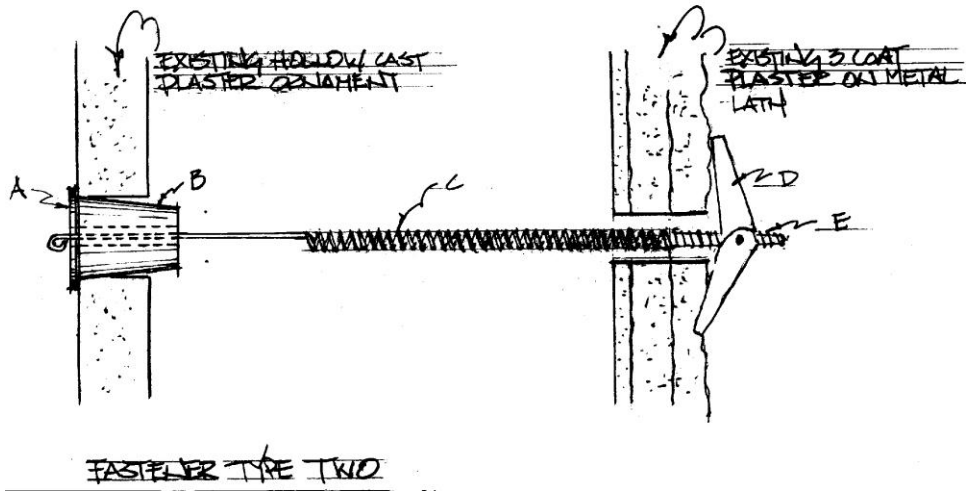
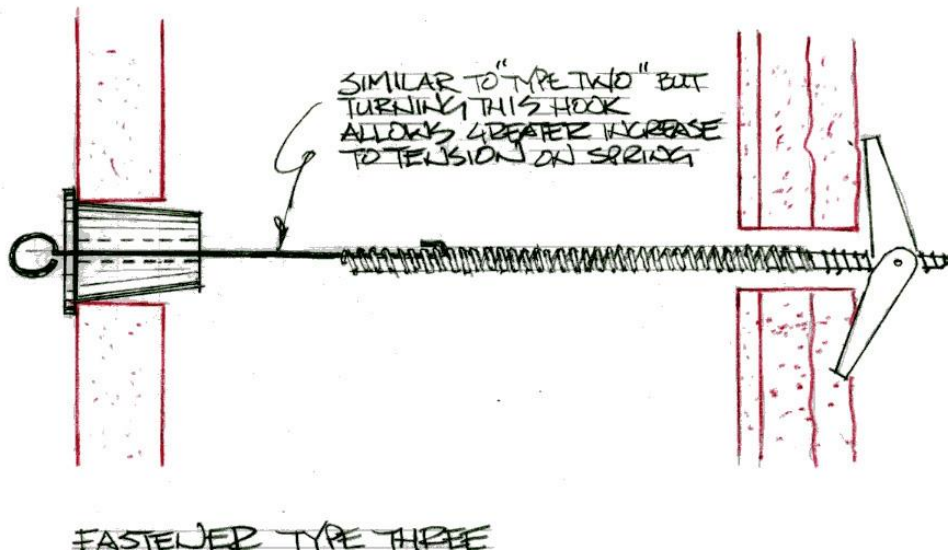
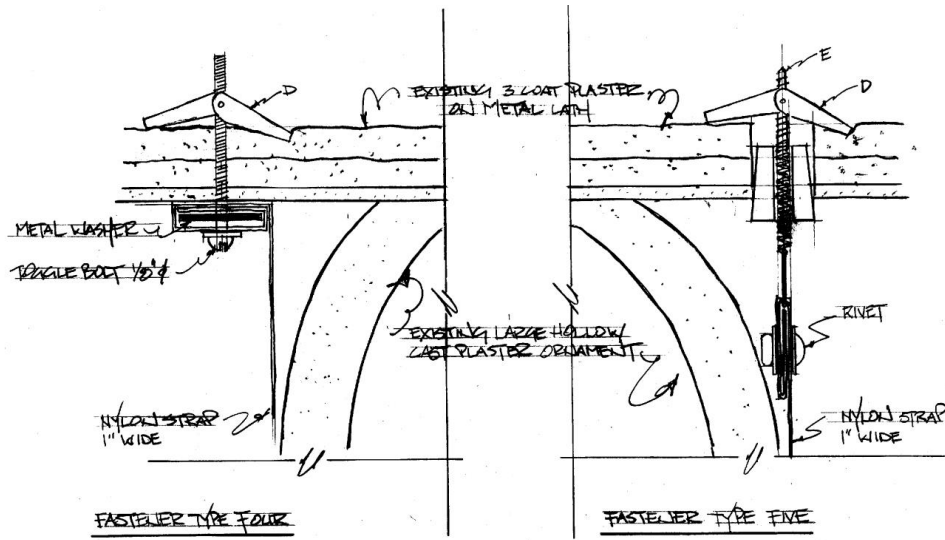
A major focus of the LOP project involved seismic upgrading of the building. In accordance with this requirement, a major focus of the plaster conservation was seismic upgrading. A set of five similar but slightly different fasteners was designed to meet the specific needs of each plaster element to be re-fastened.

Springs are made from .032 Stainless Type 302 ,ASTM A313 (tensile strength 282 -310 ksi (1945 – 2135 MPa)

A spring with a screw insert (aprox. 30 coils active) will withstand force of 8 – 9 lbs. before taking a set. The term set in spring parlance is the point where a spring does not return to its original length.

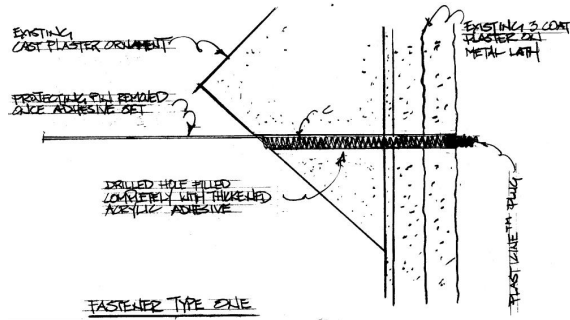
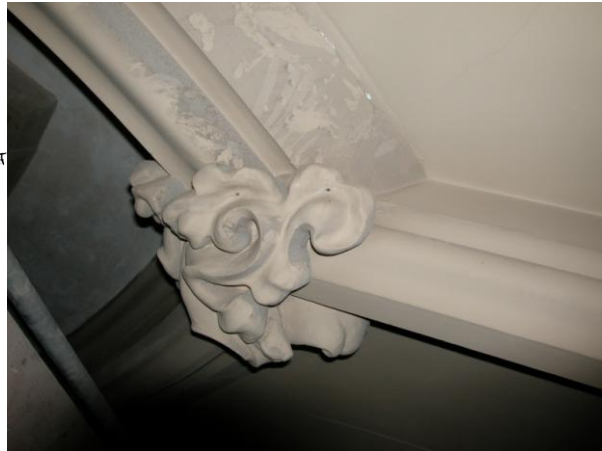
The 16 principal windows standing above the library drum are each headed with one of four different plaster ornaments that consist of several different components. The conservation consisted of insertion of HPCS Helix Pins™. The location and number of pins varied as required by the particular conditions. Typically each window head required the insertion of between 8 and 12 individual pins. Pins were installed according to the method described on the HPCS Plaster Condition Survey (see appendix). In total, 180 pins were installed to secure these elements.

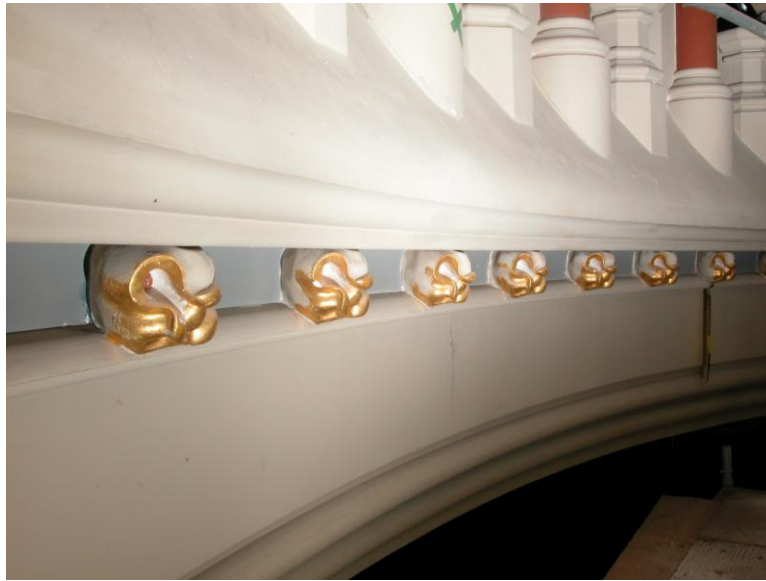
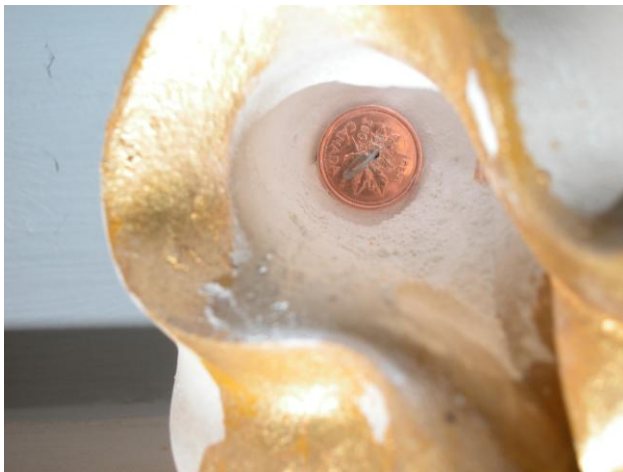
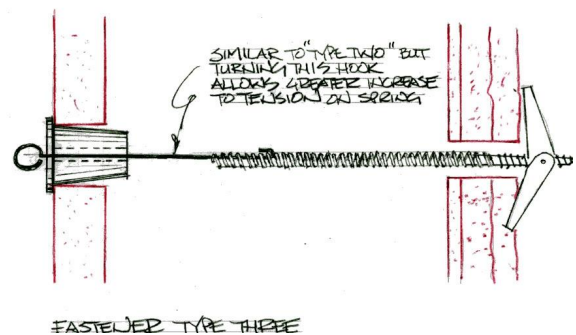
64 gilded Spherical Leaves ring the upper library in a groove just above the terminating ring of the ribs. These elements were originally attached with the simple method of slathering a blob of plaster of Paris on the back of the element and holding it in place until the plaster set. The original survey indicated that several of these pieces had become detached.

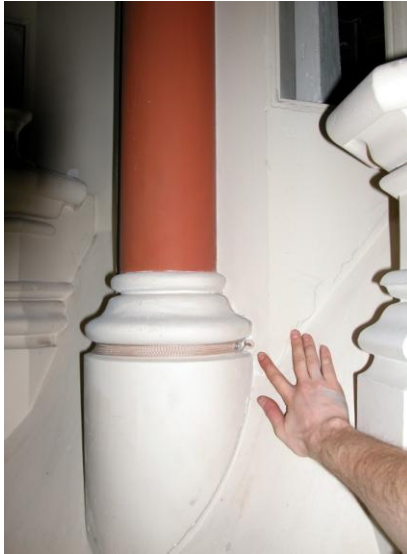
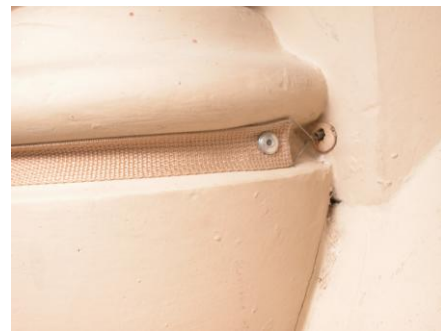
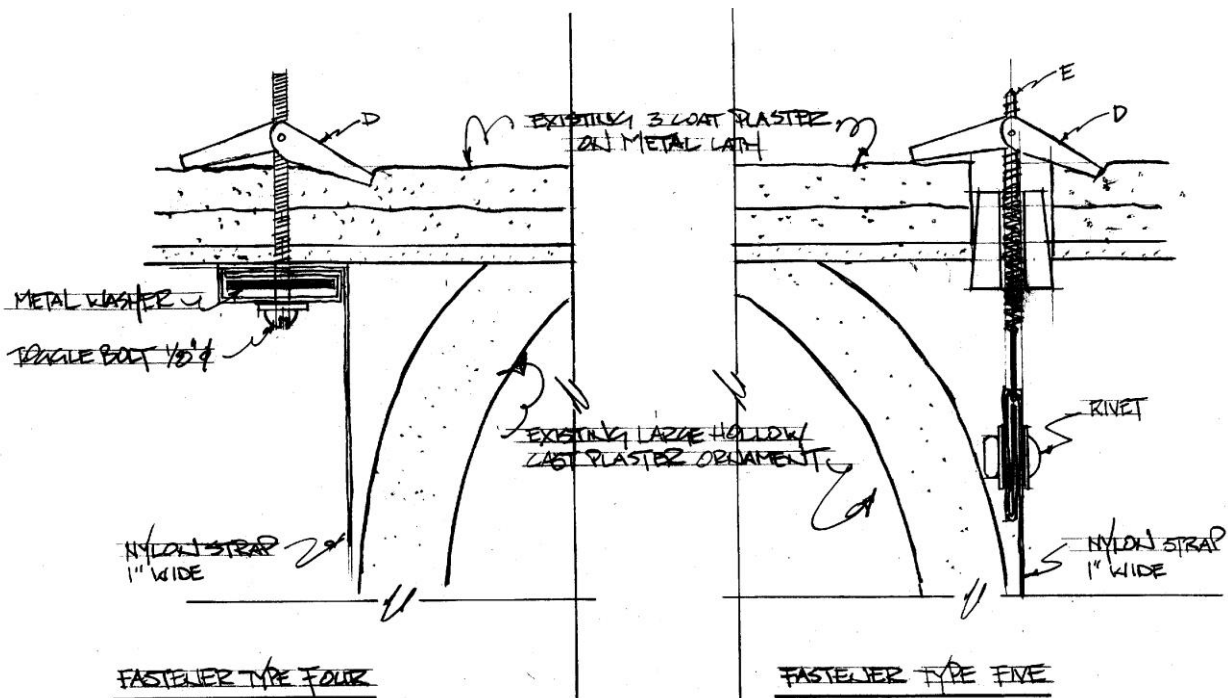
The 16 column bases are a thin walled casting mounted with a simple blob of plaster of Paris. A single point of contact would be very likely to break under any significant stress. The polypropylene strap spreads our contact over about 24 square inches and makes contact at a fairly robust part of the element. Fastener types 4 and 5 are used in tandem, one at each end of the 1" poly strap.

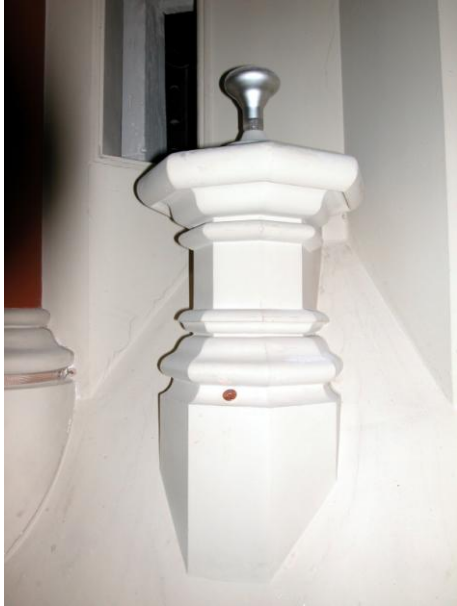
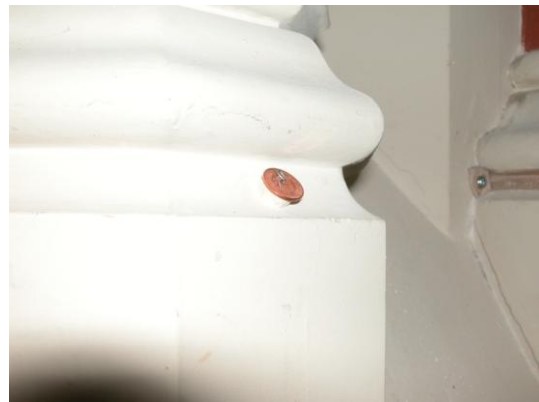
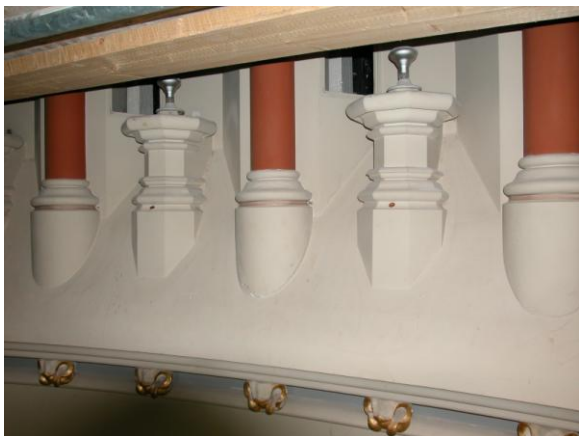
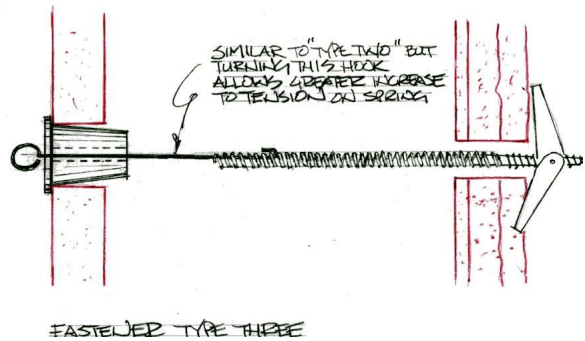
The 16 truncated octagonal lamp bases required connections. This called for a single pin inserted through a substantial section of the element connecting it through the substrate plaster.

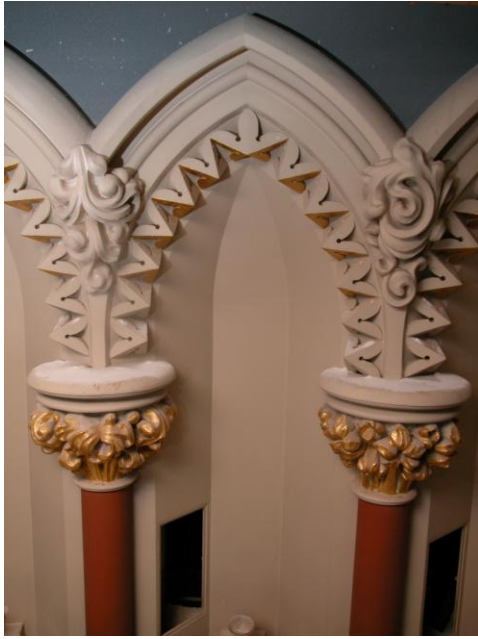
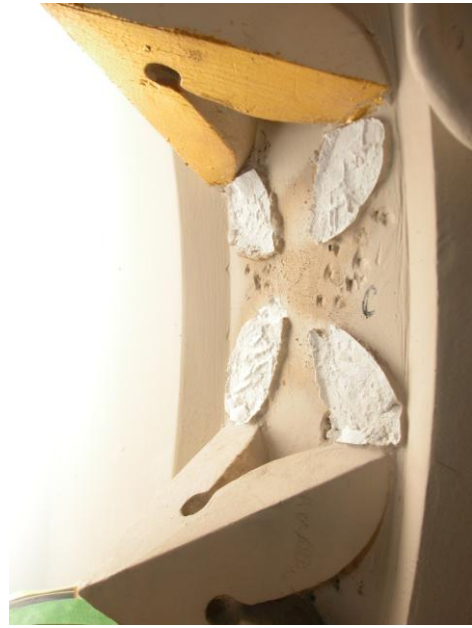
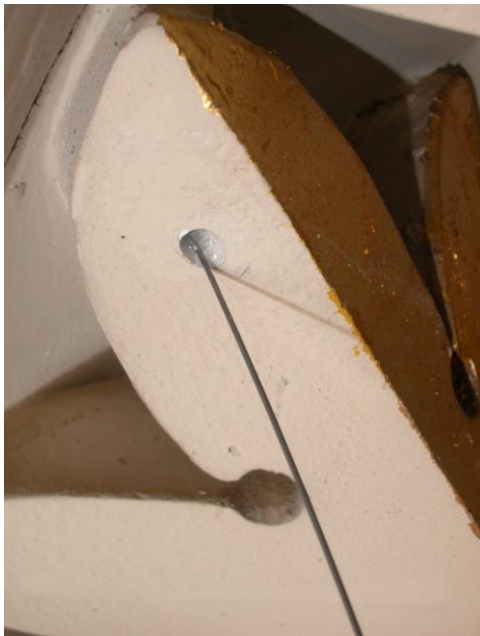
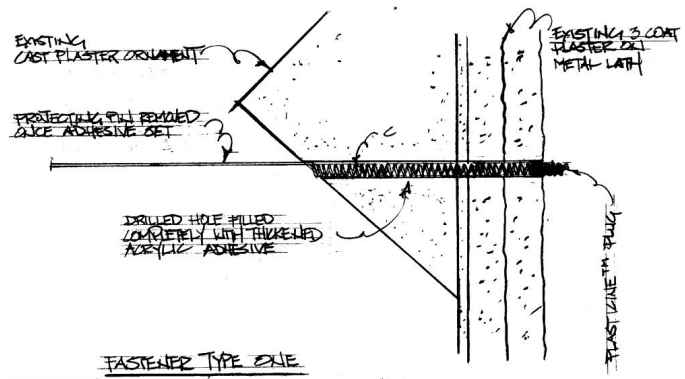
There are 640 dogs tooth ornaments surrounding the 16 lancet windows. As the images illustrate, original attachment was with simple plaster of Paris. The conservation treatment consisted of application of two simple spring pins into each of the dogs tooth ornaments.

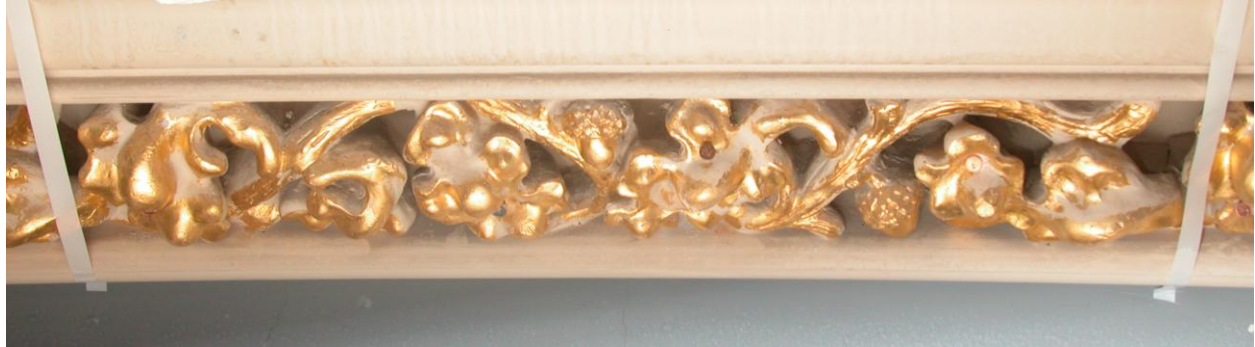
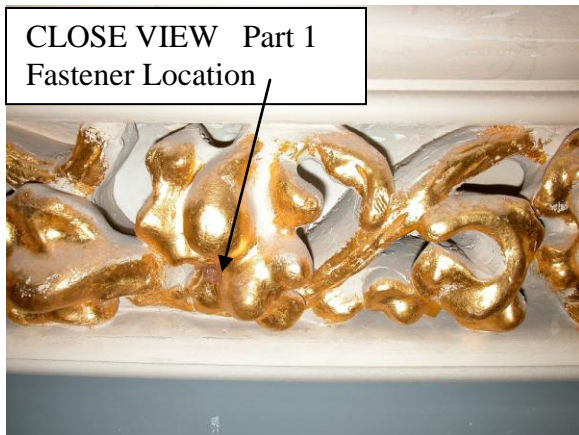
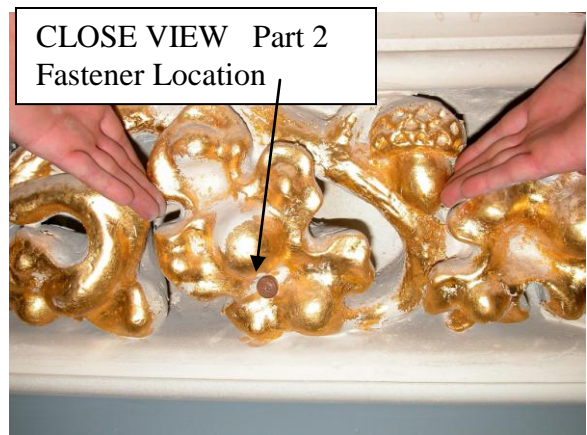
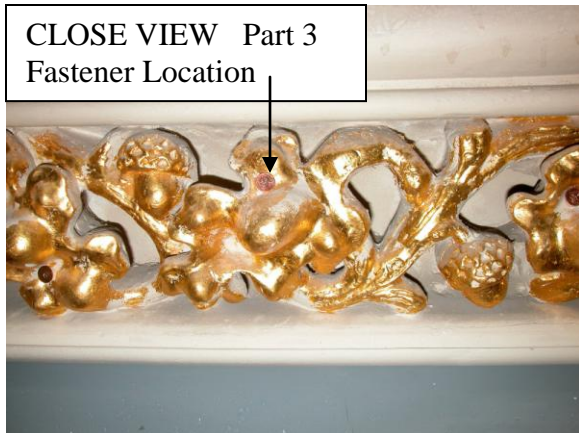
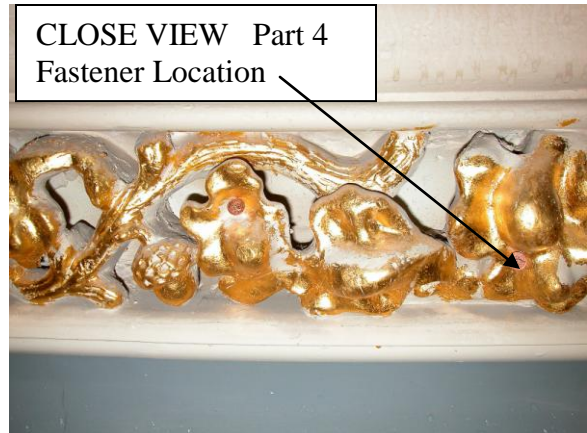
The gilded cornice at the base of the dome consists of 22 distinct pieces each approximately 48” long, and connected in place by simple plaster of Paris. Each piece of the cornice required 4 distinct attachments using Fastener Type Three.

Eighty eight fasteners were used to stabilize the gilded cornice.

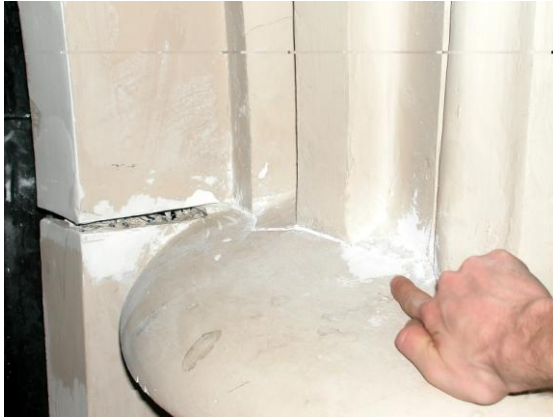
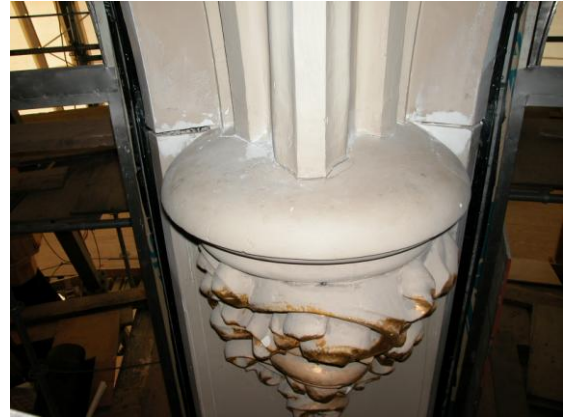
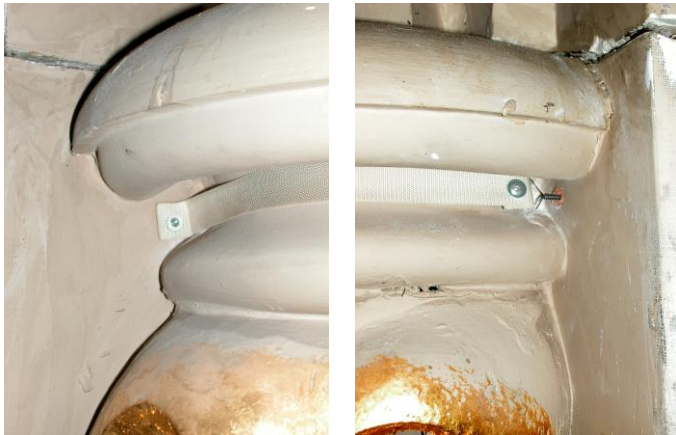
The 16 large corbels that appear to support the arches that decorate the upper dome are thin walled cast plaster fastened to the wire lath and plaster substrate plaster wall with a few randomly spaced wire connections and some plaster of Paris. The tops of these corbels are comparatively heavy. Over time, it has been observed that an unplanned expansion joint has formed around the tops of these corbels, possible in response to slight movement of the surface of the dome above. It was decided that the corbels should be stabilized and then that a forced expansion joint should be created to allow such movement as might occur to take place without damage to the ornament.

The corbels were filled, with a low density (2 lb./per cu. ft.) polyurethane foam poured through  $\frac{3}{4}$ " holes drilled through their tops. This adhered to the entire interior surface and distributed the weight of the element evenly across the plaster substrate wall surface.

The heavy corbel tops were anchored to the substrate wall with straps of polypropylene connected with Fastener Type 4.

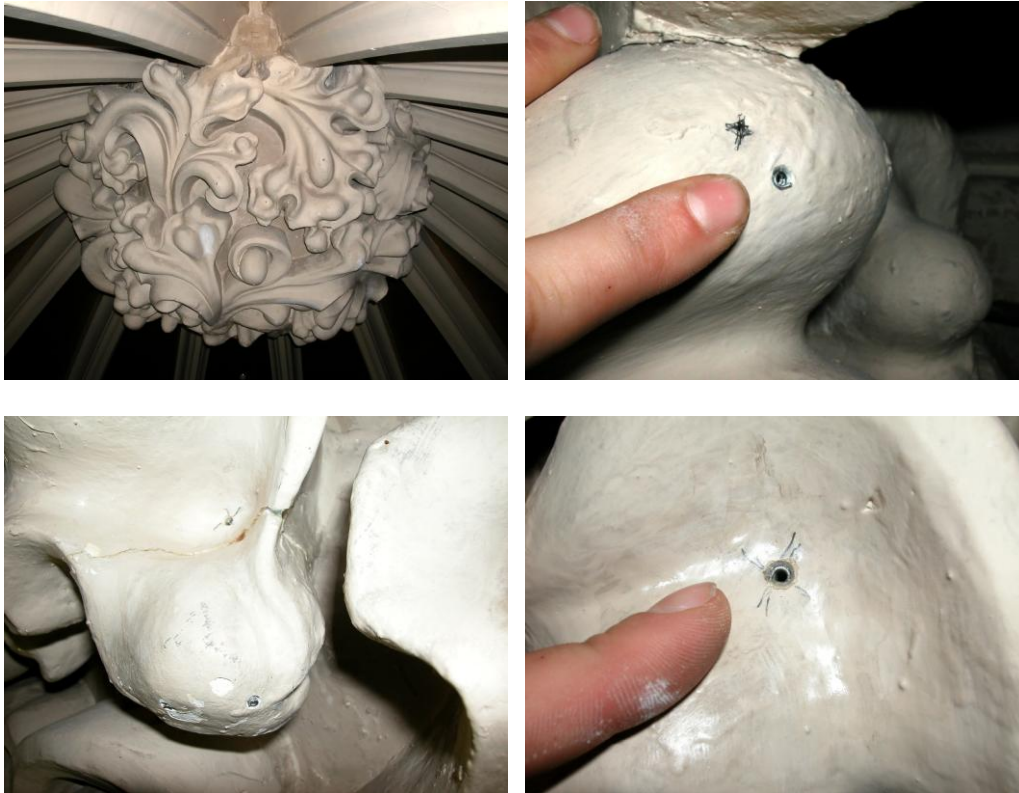
The large central boss is connected to the structure by a series of connecting wires and metal bars. None of these connections is well understood, and their quality and integrity could not be verified. In addition, the boss itself was found to have interior weaknesses typical of this kind of fabricated element.

The boss was pinned at over 150 locations across its surface. The intention was to ensure the connection of the boss surface treatment to the interior sphere. Fastener Type 1 was found to be effective for this treatment.

Elements that broke off the surface of the boss during the examination were re-connected using Fastener Type 1 and HPCS acrylic resin.
