# Plaster Conservation Report Gould Memorial Library, Bronx Community College

Prepared by  
Historic Plaster Conservation Services  
Limited

August 2002.

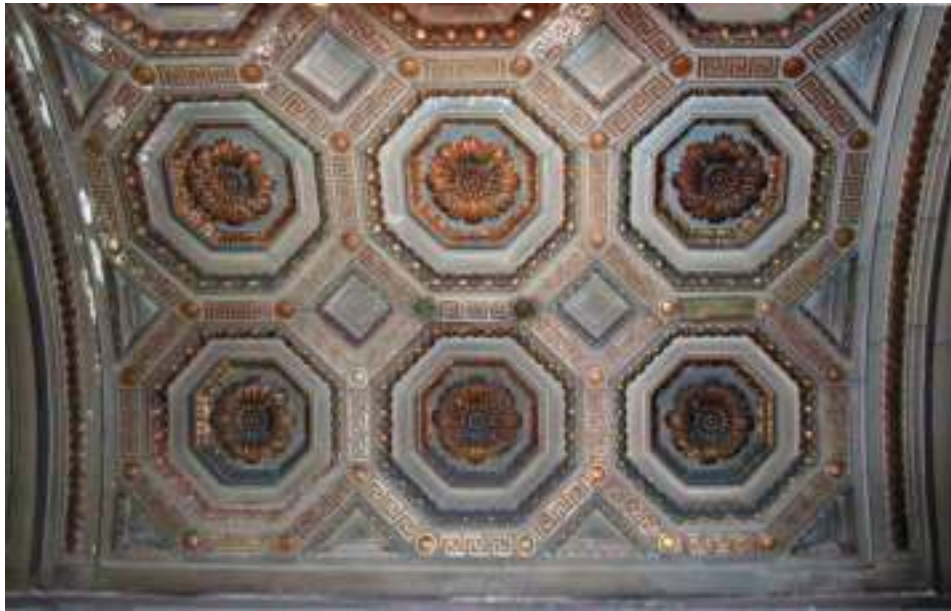
This is the northwest section of the lower entry ceiling prior to cleaning. The green-beige areas appeared splotchy and dark. The dust and soot layer was so thick it completely obscured the gold ornamentation, particularly the lower portions of the concentric octagons of gold leaves and egg and dart. Past attempts have been made to hide some of the missing ornamentation by painting the stark white exposed plaster with an olive green color. To the left there is an indication of a paint-adhesion problem. Upon closer inspection it is apparent the cause is water infiltration.

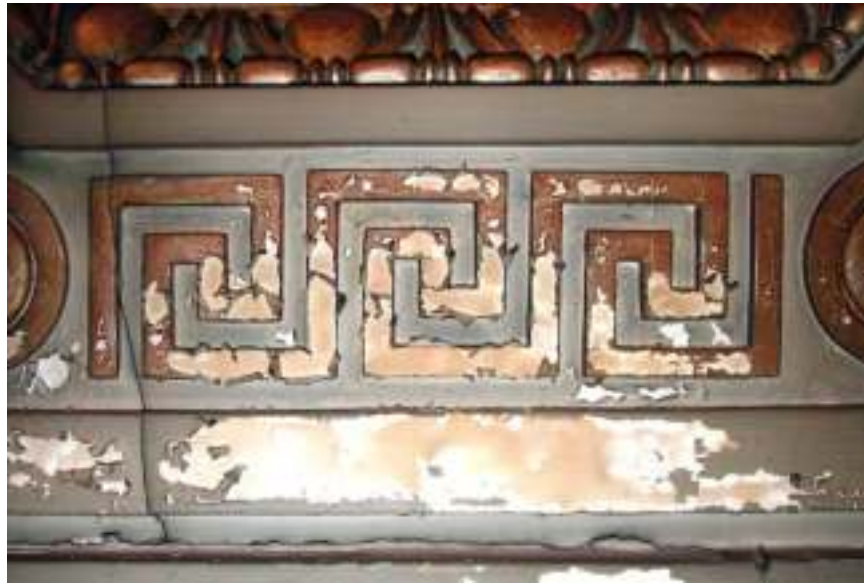
Much of the paint above the lower entry was in very poor condition. This photograph was taken before cleaning and shows the green background and the peeling gold paint. The staining on the bare plaster is an indication that the cause of the problem is water infiltration. This paint was so fragile that most of it flaked off the plaster during cleaning.

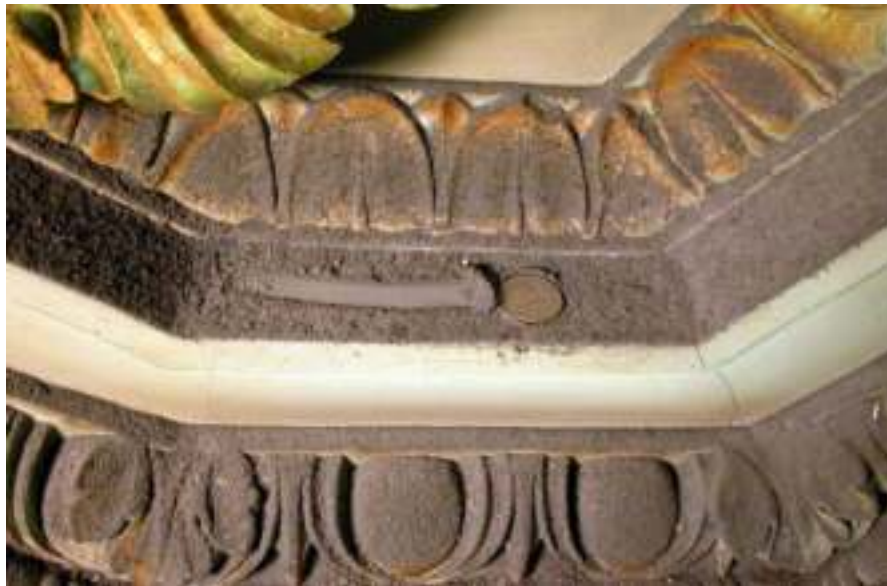
This was the typical condition of the ceiling before cleaning. A 1/8" – 1/4" layer of dust and soot obscured all the fine details of the plaster as well as most visible signs of fracture or instability.

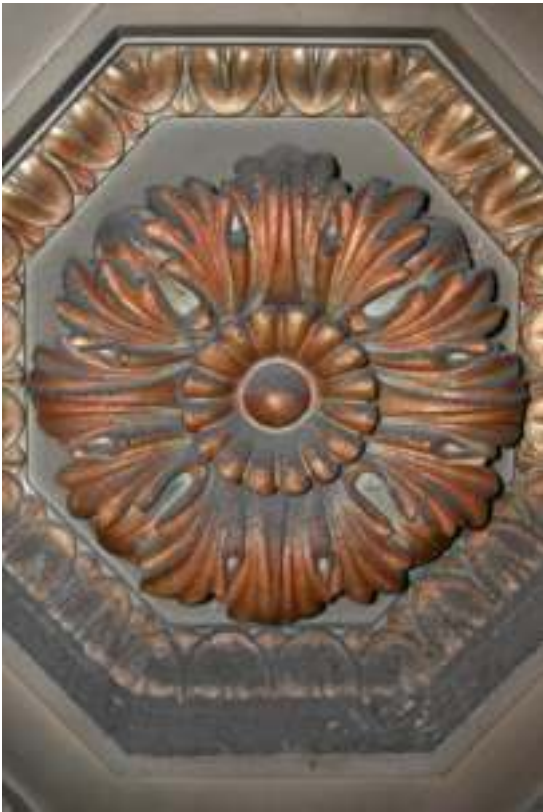
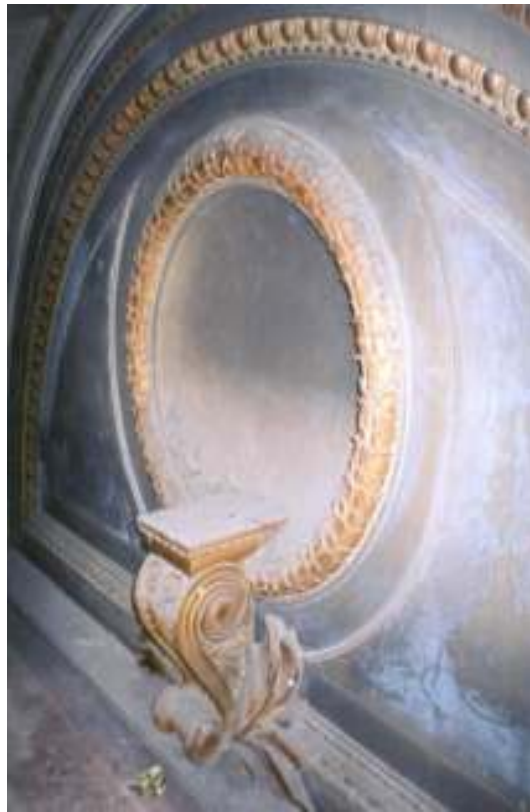
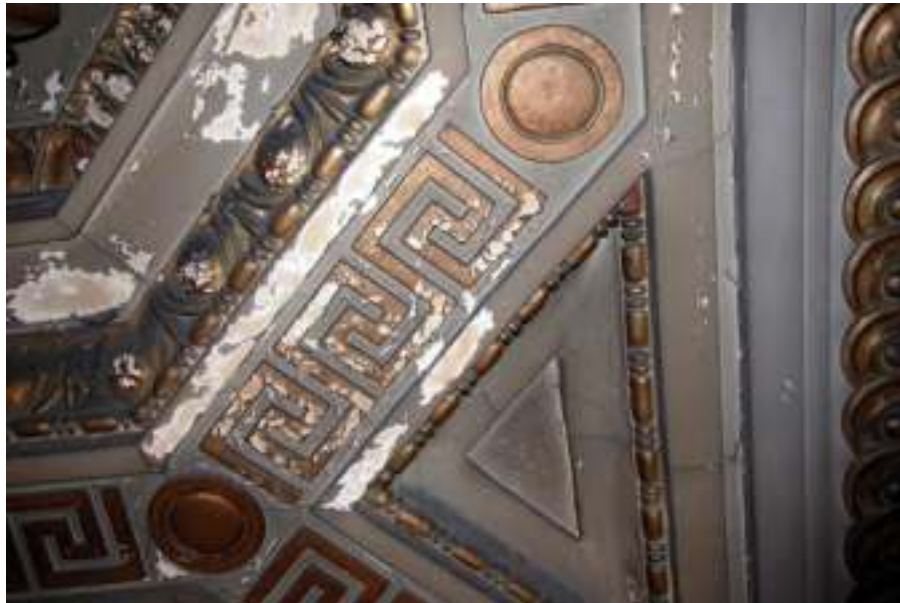
A typical water-damaged area on the southwest side of the lower entry stairway ceiling.

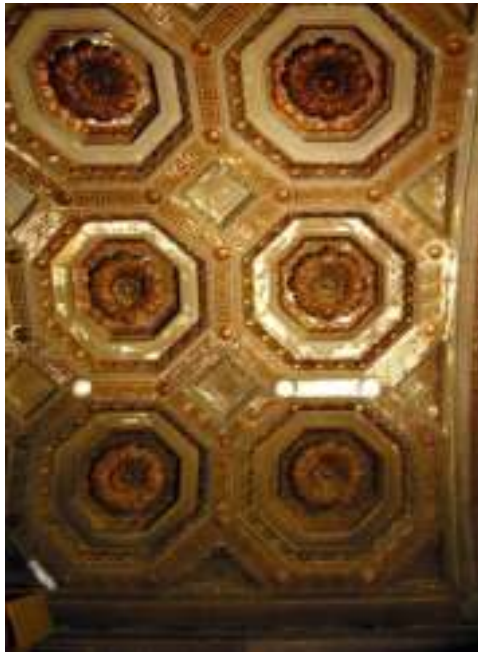
This is a portion of the lower entry ceiling at the northeast side after cleaning. The background paint color was permanently soiled in some areas and the deteriorated condition of the paint finish is much more apparent.

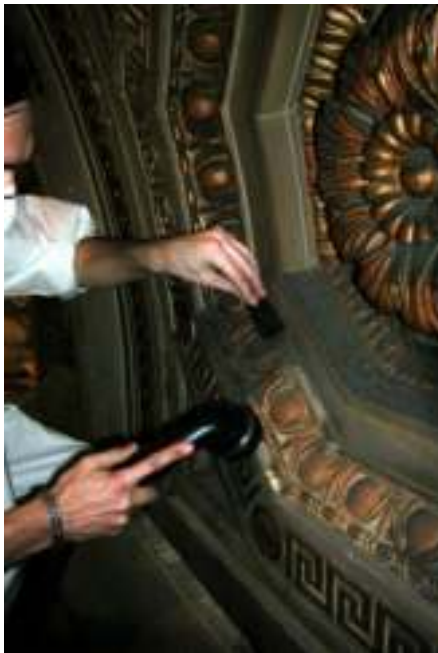
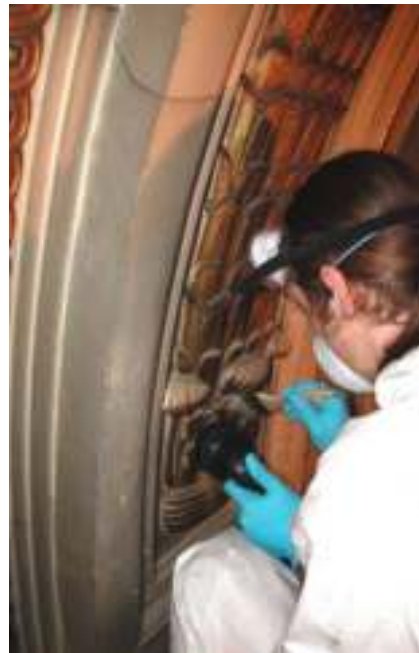
High-power vacuums and brushes were used initially to remove the bulk of the dust. The dust was slightly oily and required some agitation before the vacuums could remove it. In areas where there had been a lot of soot, some of the gold ornamentation was found to be permanently dulled.

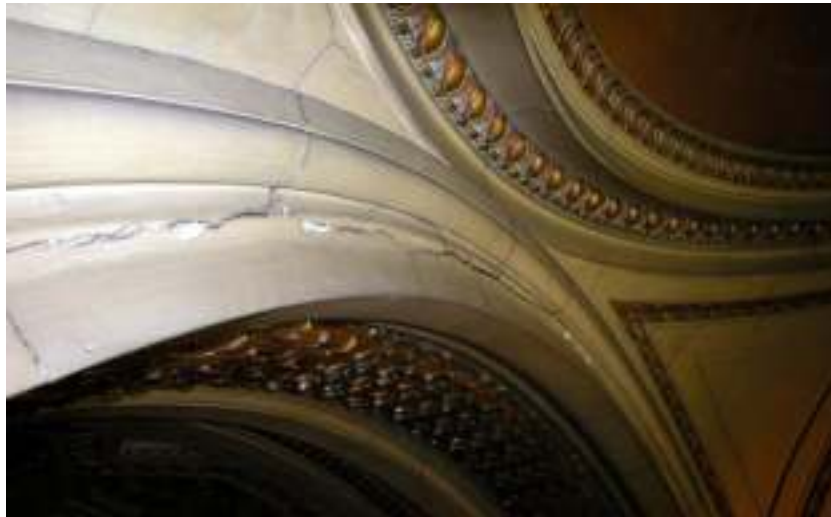
All the arch bands were in very bad condition. Prior to consolidation, large portions of the bands were threatening to collapse with the slightest encouragement.

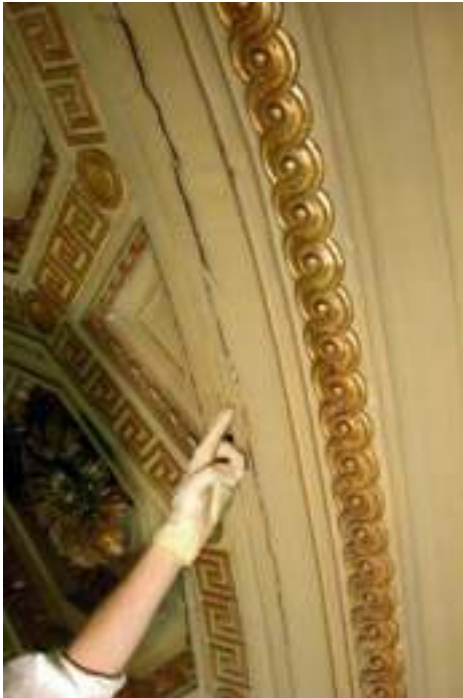
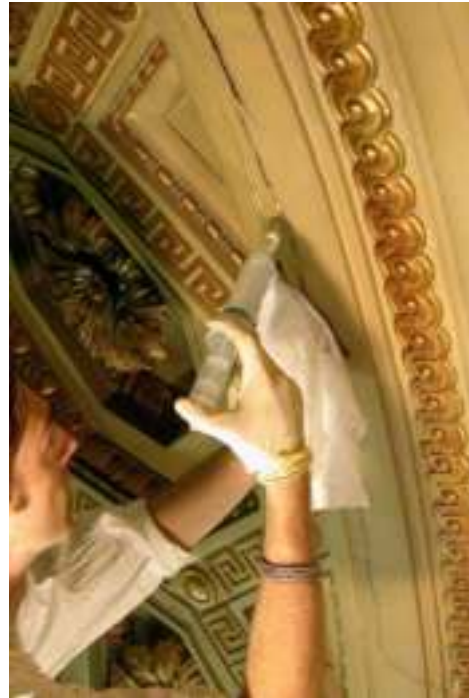
Some faults are so obvious they do not require sounding to determine that they are structurally significant. Once identified as an area for repair, the fracture is injected with an alcohol pre-wetting agent. This agent cleans dirt and debris from the fracture as well as preparing the plaster to absorb the injected acrylic consolidator that is applied next. In cases where a structurally significant fracture is too narrow to fit a hypodermic needle tip, a small hole (1/16" – 1/8") is drilled to inject material.

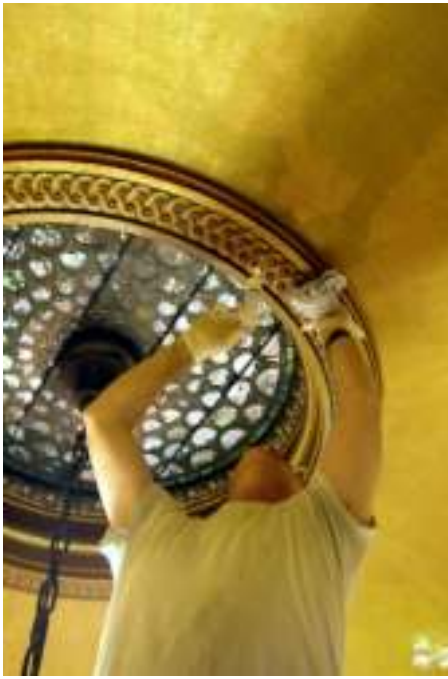
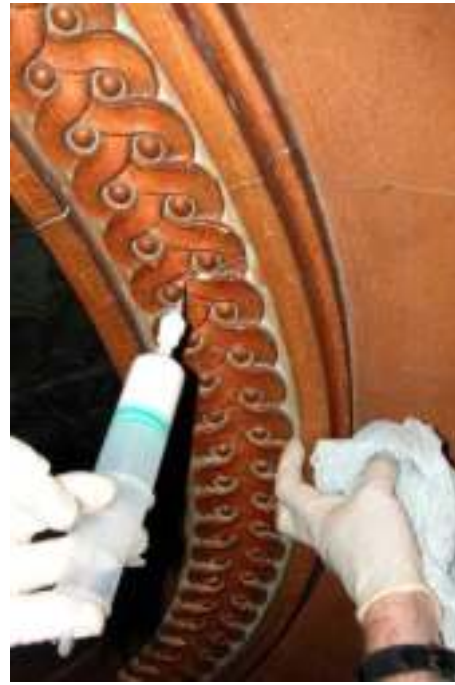
The condition of the finish on the ribbon band encircling the oculus above the upper hall was excellent, so the utmost care was taken to preserve it. Properly pre-wet cracks in the band absorbed the low-viscosity, injectable acrylic with a minimal amount of leakage, thus avoiding damage to the original paint.

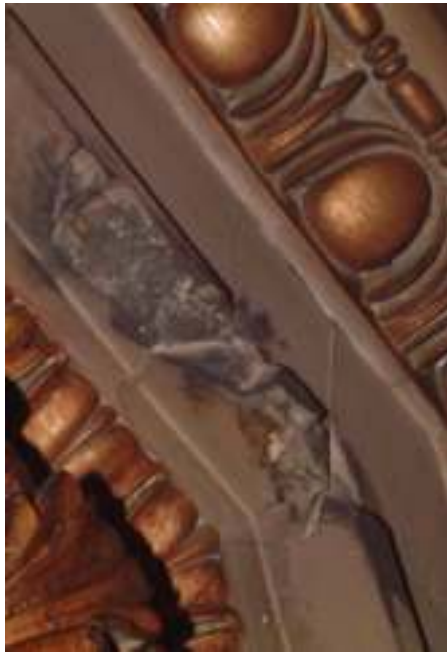
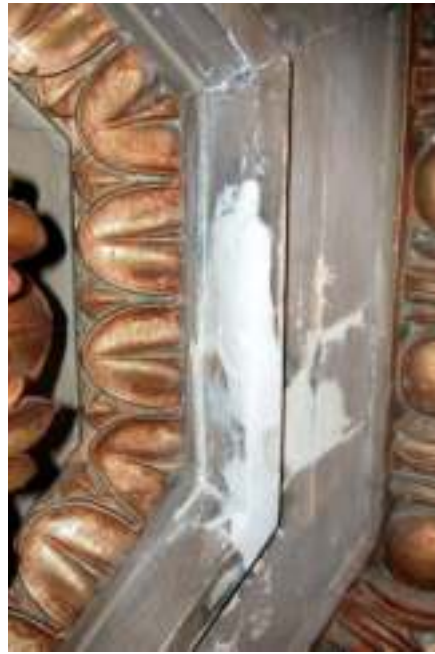
Some fragments of plaster had been lost from this damaged area of the ceiling. A previous attempt had been made to obscure the damage by painting the bare plaster gray. We used plaster of Paris to remodel the missing edge.

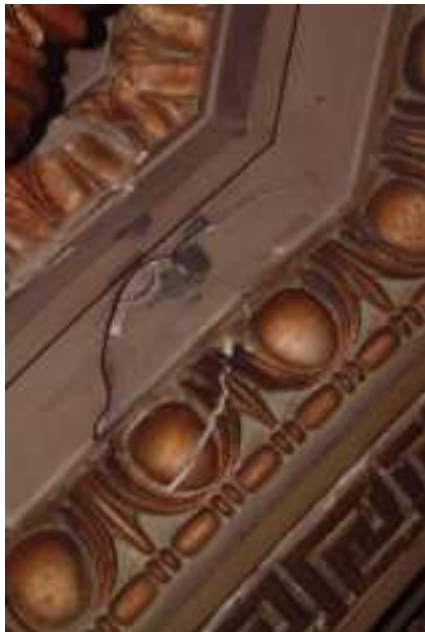
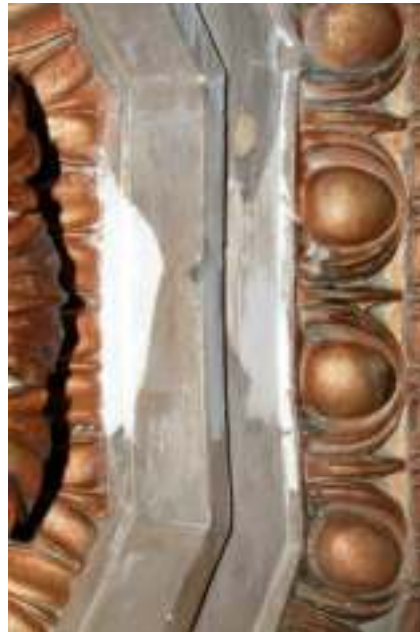
During cleaning, a large portion of the fractured area became dislodged and fell from the ceiling (photo on left). The portion of egg and dart was saved and re-adhered. The flat panels were repaired with plaster of Paris.

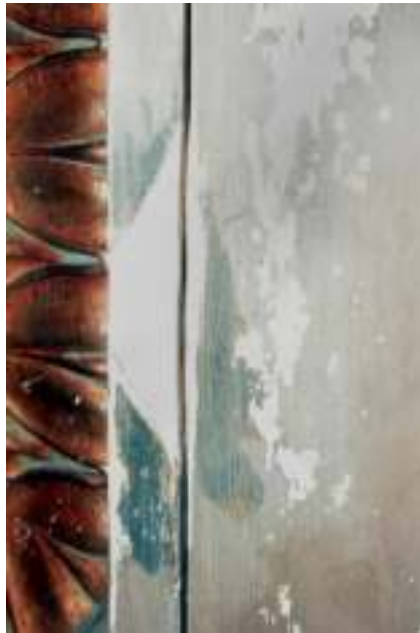
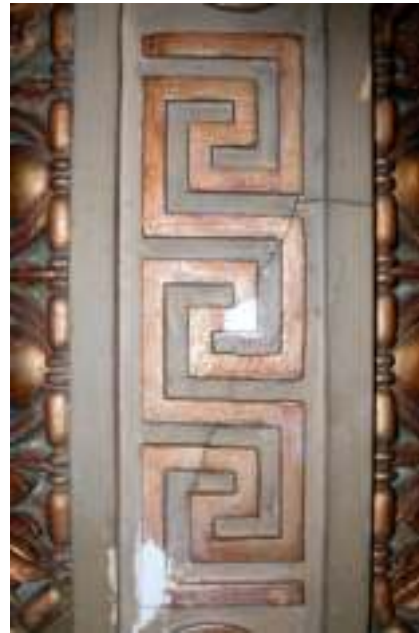
The stark white areas in these photos are HPCS repairs. Over the entire work surface there were about twenty chips and dislodged bits of plaster that were apparent enough to warrant this type of repair.

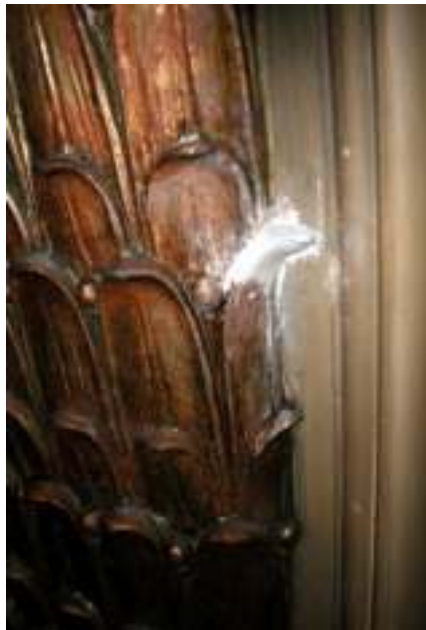
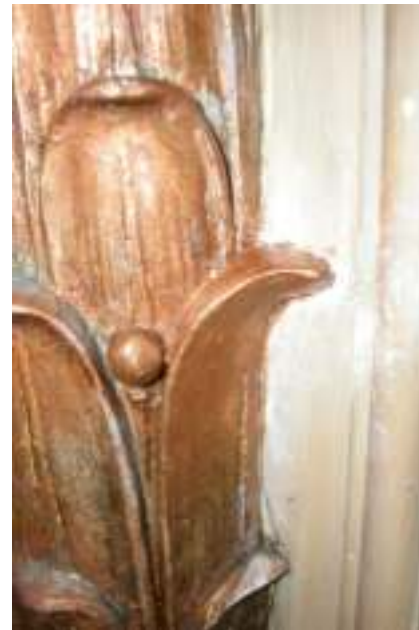
About half-a-dozen leaf tips were re-sculpted on the cross vault borders. The photo on the right shows a remodeled leaf tip that has been painted. (The background beige had not been applied at the time of this photograph.)

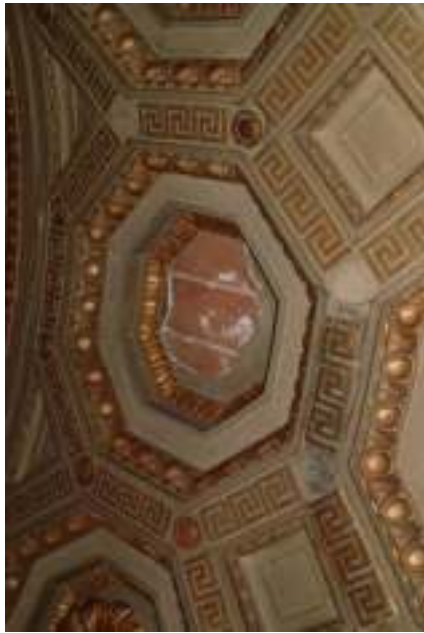
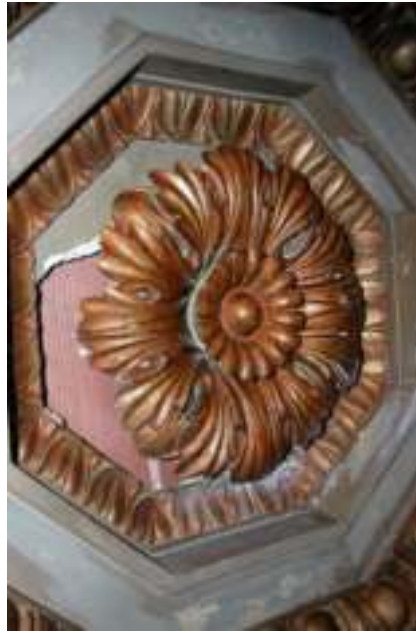
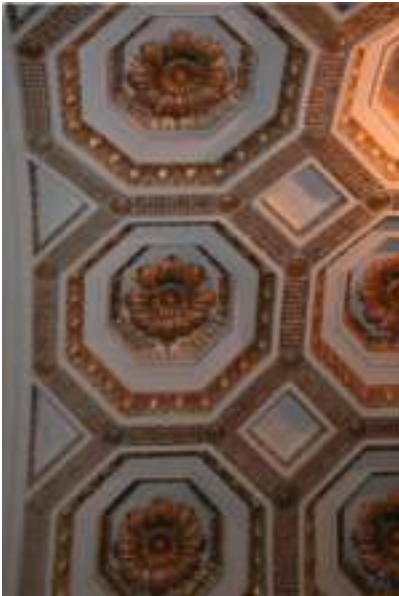
This rosette became detached when sounded. It was reattached successfully to the tile substrate using HPCS acrylic adhesive. A half-inch hole was drilled through the center of the rosette and a stainless steel anchor was installed as a backup safety measure.

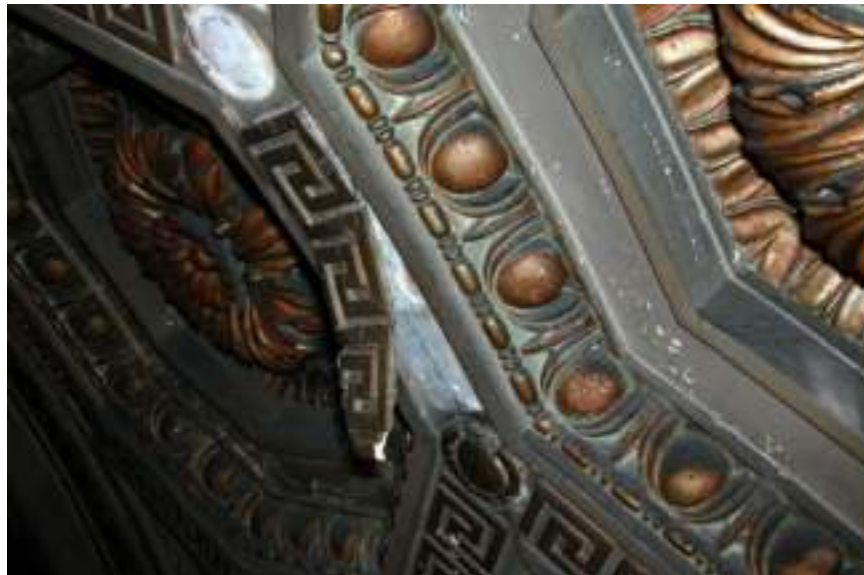
Prior to cleaning, several key strips were dangling from the ceiling and several more fell off in our hands with the slightest touch. Past attempts had been made to conceal some of the missing decorations by painting the bare white plaster a dirty green color. We replaced all the missing or severely damaged ornaments with accurate replicas.

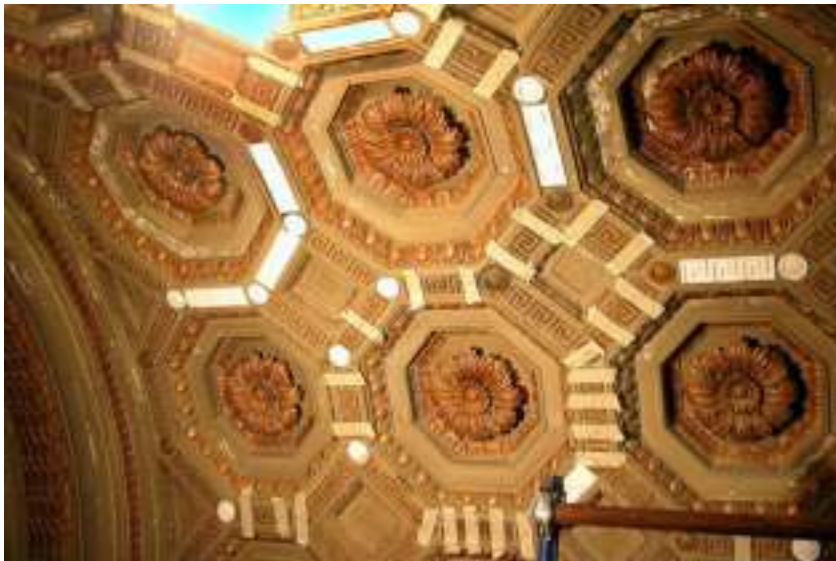
This is the southwest side of the lower entry hall ceiling. Masking tape was used to secure the reattached ornaments while the acrylic adhesive coalesced. Some unpainted replicas are also in place in this photograph. Due to their weight, the replica Greek key strips were held in place with screws while the adhesive set.
