Notre Dame Cathedral
Ottawa, Ontario

Plaster Conservation at Notre Dame Cathedral

Report compiled by

Rod Stewart
Historic Plaster Conservation Services Limited
26 Barrett Street,
Port Hope, Ontario L1A 1M7

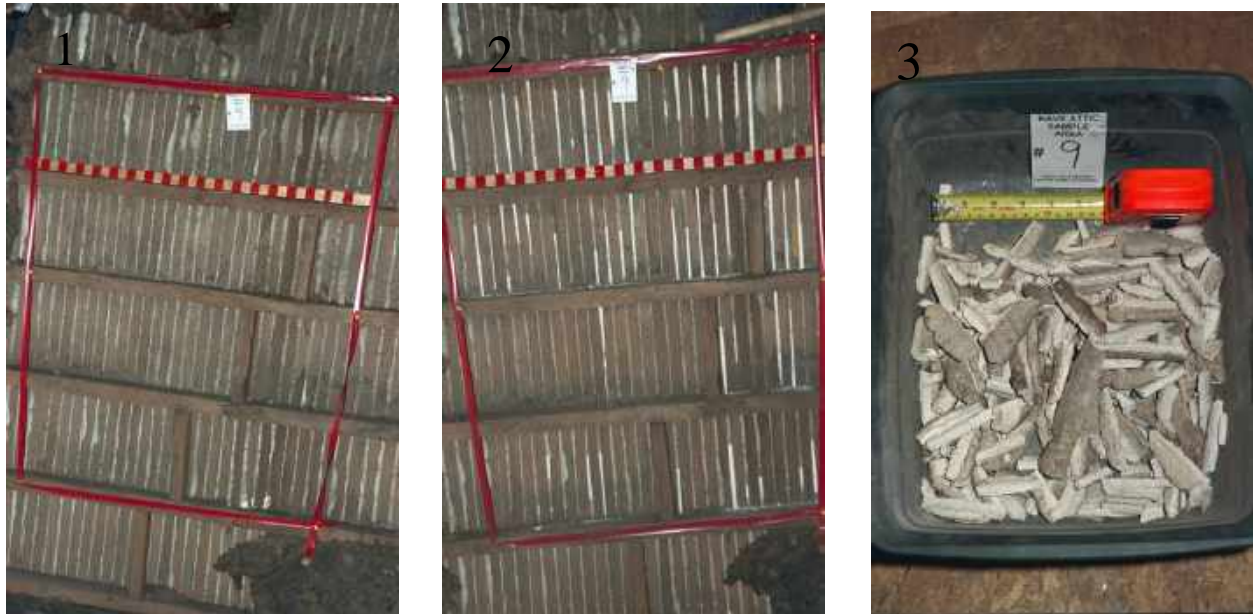
Typical conditions illustrated in the HPCS pre-conservation plaster condition report.

- 1 Typical test section of plaster after insulation removal before testing of the lugs.
- 2 The same section after lug testing and cleaning. White sections are removed lugs.
- 3 Removed material.

In Test Area 9, shown above, there was a total of 105 linear feet of effective lugs. 36 linear feet were found broken. The percentage of unsound plaster was therefore 34%. 20 test areas were examined.

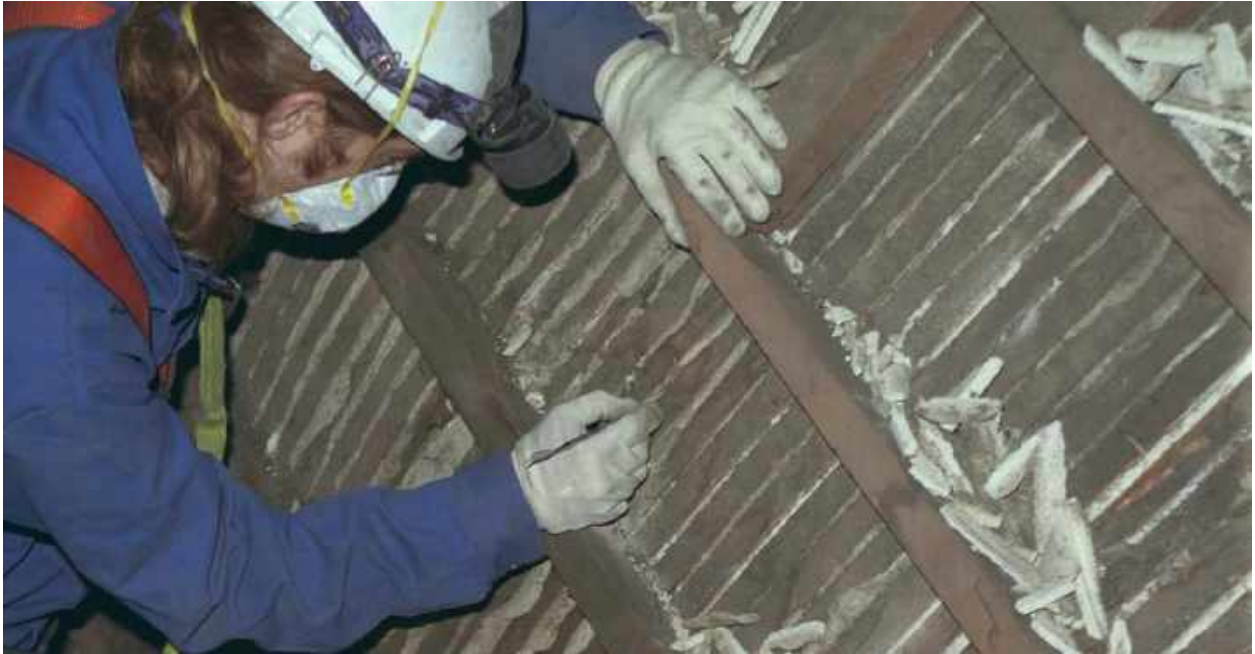
Large quantities of loose broken plaster and debris of all sorts was removed from the attic. Only after this kind of thorough cleaning can the plaster be successfully consolidated. Once cleaned, the plaster is ready for consolidation.

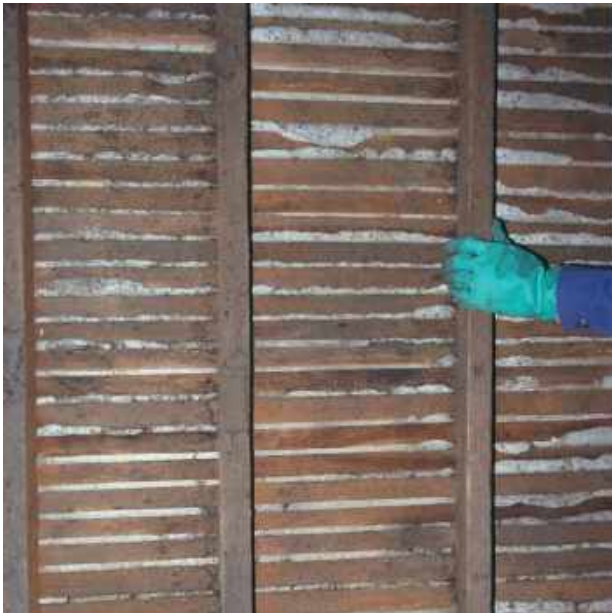
Cleaned and ready for consolidation.

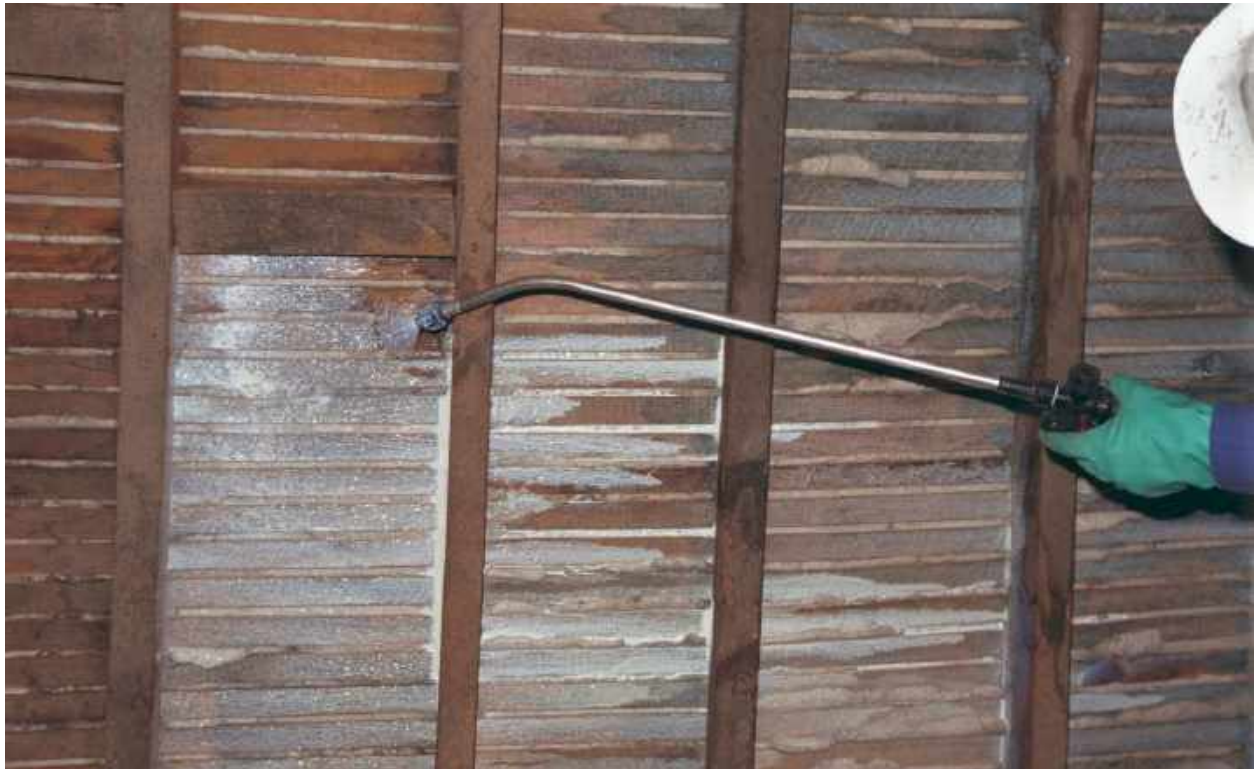
Much of the debris and garbage that had accumulated in the attic over the past century was a potential fire hazard.

A dilute mixture of acrylic resin and methanol (15% resin) was spray applied to the surface with agricultural backpack sprayers. The methanol, acting as a surfactant, wets the surface and allows the resin to penetrate deep into the plaster. Three applications of diluted resin (15%, 30%, and 50%) were done, finishing with an undiluted final coating of resin. In this process, the methanol evaporates into the attic

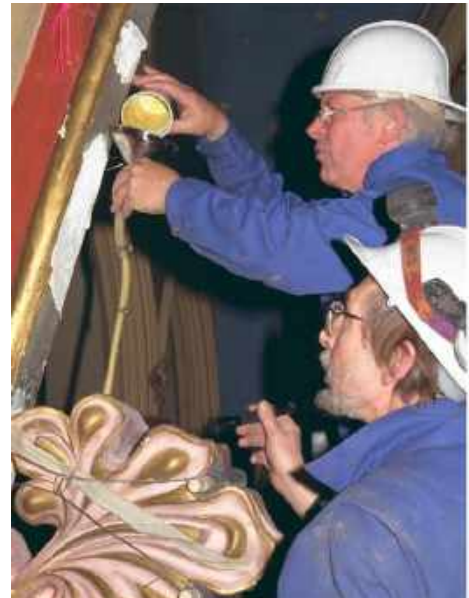
The original fastenings were simple wires bent in a "U" shape and

embedded in both the crocket and the cathedral rib during installation.

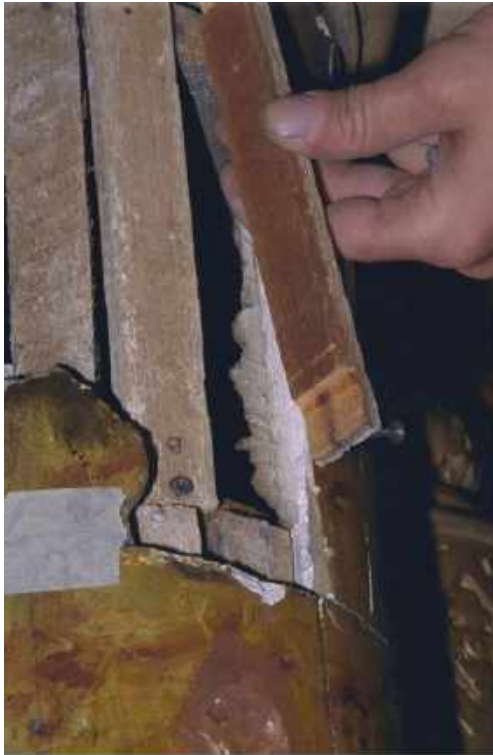
Typically, any conventional repair would have been at the expense of marble faux finish. Conservation here included removal of a previous repair.
