Marble Conservation at the Dominion Public Building, Hamilton, Ontario

Rod Stewart

Abstract

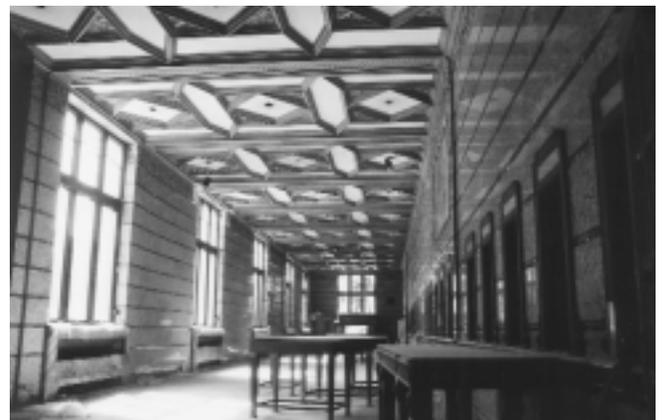
Figure 2. Postal hall of the Dominion Public Building is clad floor-to-ceiling in marble.

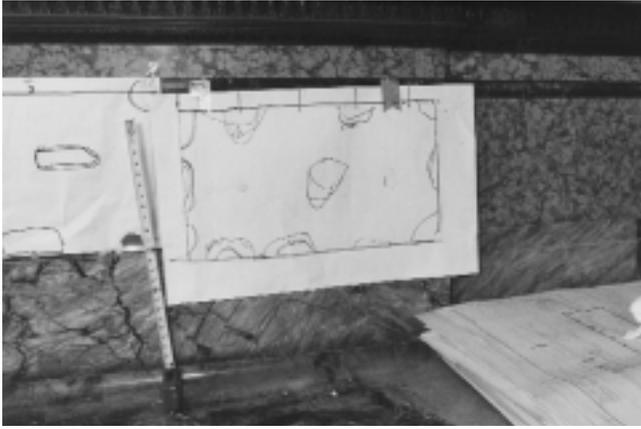
Figure 5. In our blind test, the technician made these marks on newsprint taped to the marble surface.

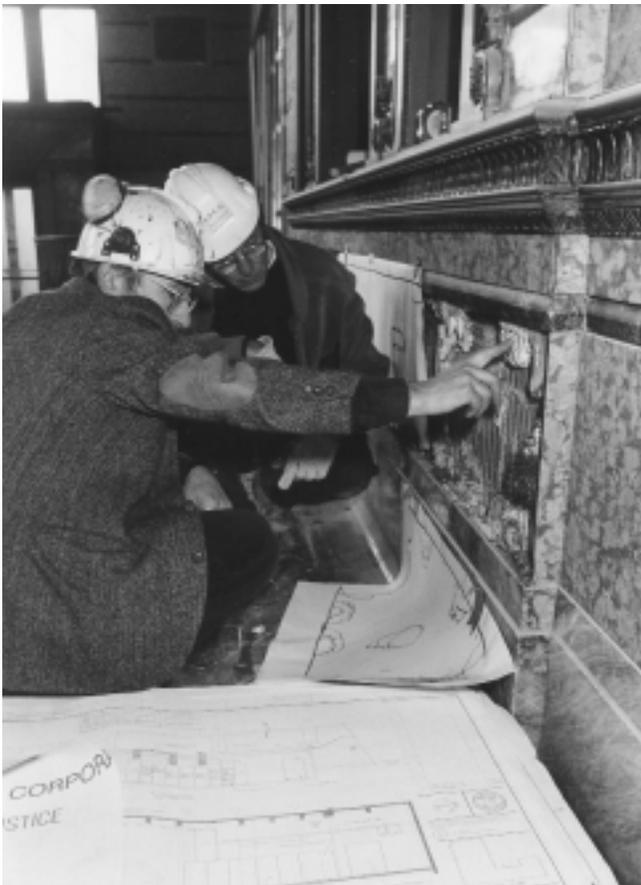
Figure 6. Once the test indicated that the procedure located the plaster adhesive patches with 90% accuracy, the survey continued.

found that most long slabs had three patches along the top edge, one on each end (over the wires), and one or two along the bottom edge. Any plaster in the middle seemed to have been put in at random and was of little consequence. It was probably placed there to cut down on possible vibration of longer slabs.

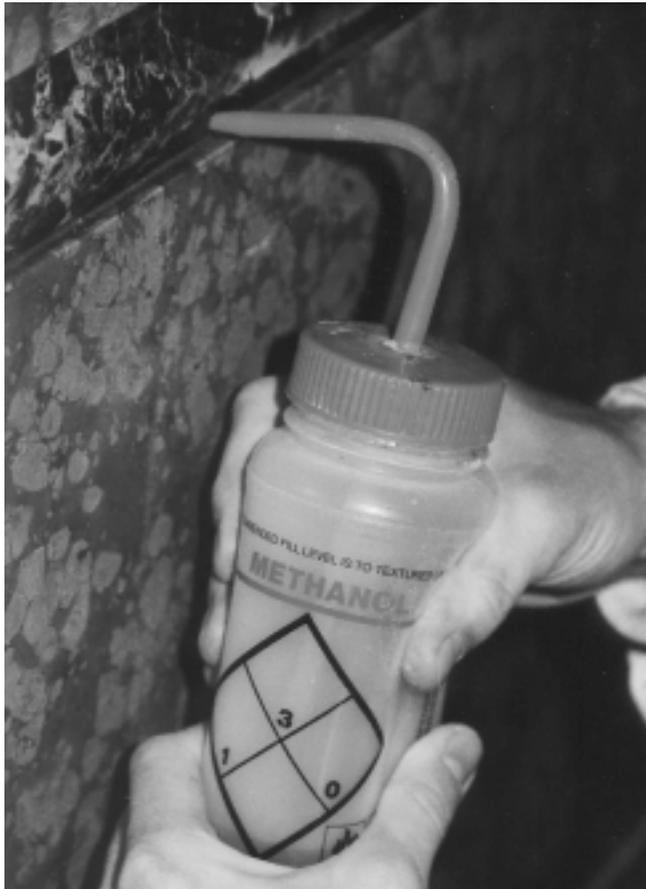
Figure 7. Methanol rinse being applied.

In the case that the methanol was absorbed freely into a void (and this was readily noticeable with some experience), we concluded that we had discovered a break at the connection between the marble and the plaster. The treatment for this type of break is described below.

squeeze bottle. This rinsed out or dislodged any polishing rouge on the face of the marble. If the material streamed back out of the hole as quickly as it was delivered, we determined that there was probably no void to be found at this depth in this location. Several attempts were made along the grout line at this depth before it was considered sound. Because we knew that there had been a rattle here when this spot was sounded, we therefore could conclude that the break was to be found at the next level (i.e. between the plaster and the terra cotta).

1. Continue to rinse the void with methanol until all the plaster face is wet and the contaminating rouge is dislodged or loosened. Some material may appear in the grout joint immediately below the subject location and this could be the result of saturation of the plaster or of the methanol wash simply running around the plaster at the surface. Experience indicated that when the material ran out immediately it was from surface run-off, whereas if run-out occurred after continued

2. Using the same tools, inject a dilute (20%) methanol/Rhoplex solution and observe its absorption. If the pre-wetting has been successful, the Rhoplex will be delivered throughout the break; it will consolidate the contaminant rouge and create the necessary bond. Repeat the injection twice, using 50% and then 100% Rhoplex. [A word about adhesives: The material selected for repairing the bonds addressed in this project is Rohm and Haas Rhoplex MC76. Rhoplex is a pure acrylic emulsion that can be diluted with methanol, thickened both chemically and with fillers. It is thixotropic (which means we can cause it to enter very fine spaces), non-toxic, water-soluble, and removable with toluene even when fully coalesced.]⁷

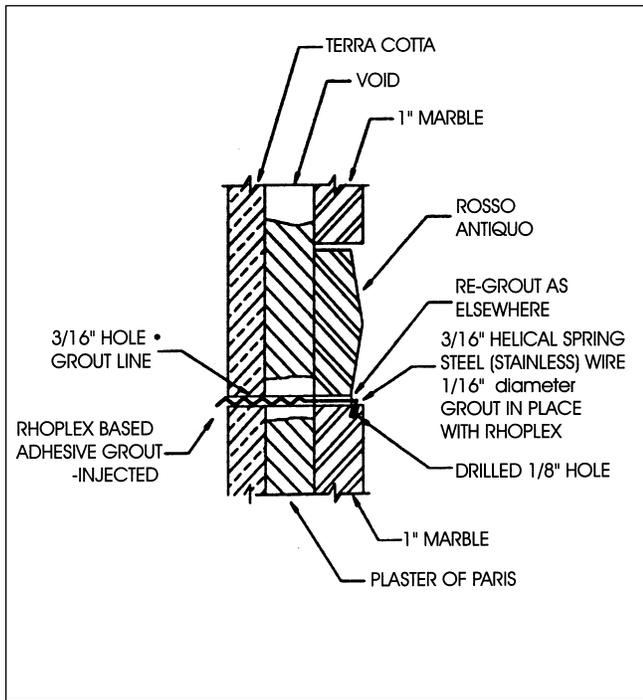
In the case of the marble cladding, the original mechanical adhesive was wholly inadequate because it only connected the marble to the face of the terra cotta with the same

Figure 8. Cross section of marble cladding and wall showing mechanical connection.

plaster of Paris adhesive that had already been seen to fail in so many locations. It was determined that three wire fasteners per average tile would be required.

Our approach was to drill three 0.5-cm ($3/16$ -in.) holes through the grout into or through the terra cotta. Along the top edge, two holes were located 15 cm (6 in.) from each end of each tile. Along the bottom edge, one hole was drilled in the centre of each slab. Some of these holes went through plaster and some went through a void (between the marble and terra cotta) and on into the terra cotta.

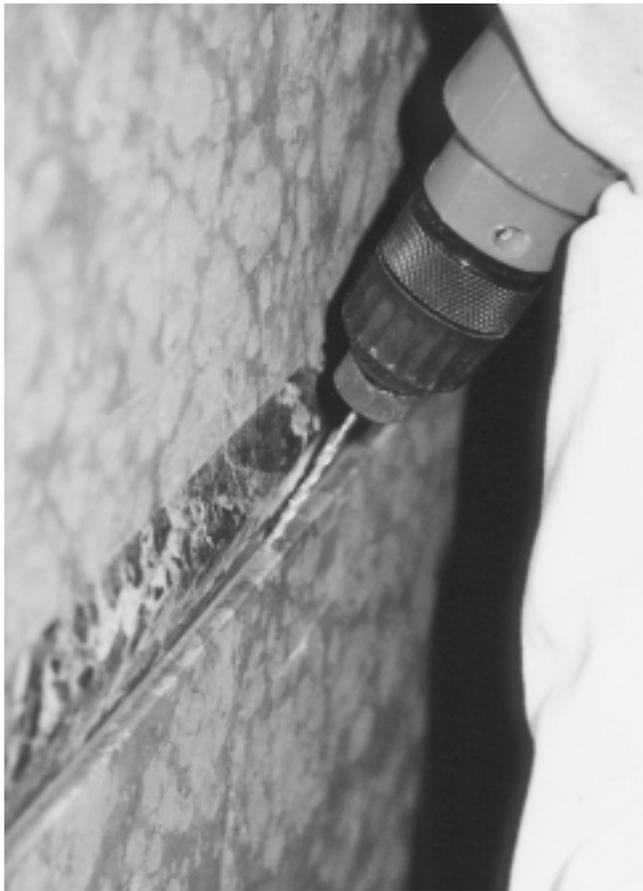
Figure 9. A 0.08-cm ($1/32$ -in.) hole drilled at 45° to accept the tail of the mechanical fastener.

A second set of holes, 0.08 cm ($1/32$ in.) in diameter, was drilled 1.25 cm ($1/2$ in.) deep at a 45° angle into the edge of the tile in line with each of these holes. A custom-made helical stainless steel wire spring with a long straight tail was inserted into these holes.⁸ The tail end was site cut to length and sharply bent for insertion.

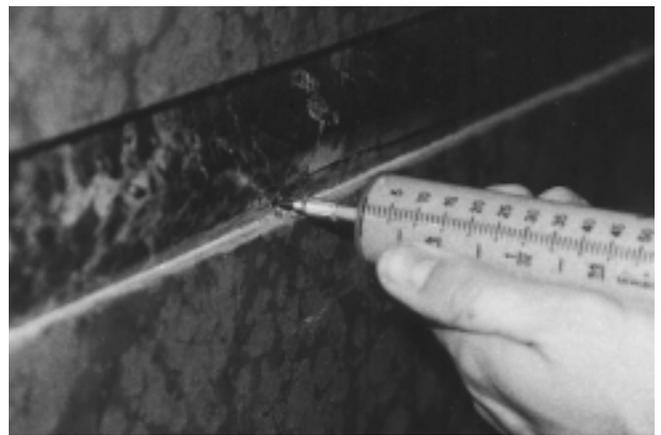
Figure 10. A filled adhesive is applied by injection through the centre of the helix to bond the stainless to the terra cotta. Once set, the straight end is fitted into the angle hole and a drop of Rhoplex placed to hold it.

The end of the helix was filled with plasticine to prevent the adhesive from running out. The hole was pre-wetted with methanol, a 50% Rhoplex/methanol mixture, and then, while still wet, injected with a filled adhesive⁹ down the centre.

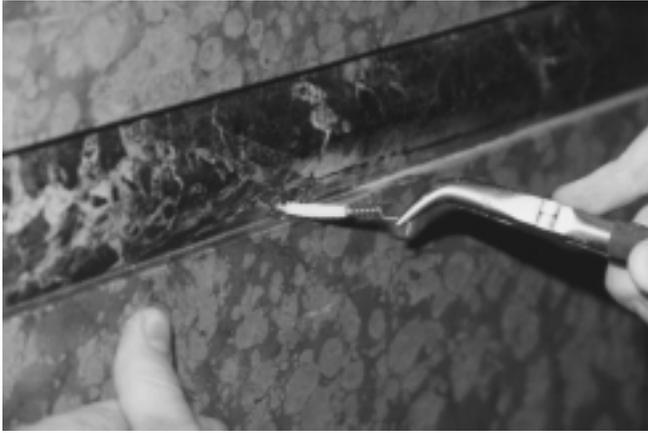
Figure 11. Stainless helical spring is inserted. Note the tail is formed to fit the hole being drilled in Figure 9.

These fasteners were very discreet once placed, but occasionally a glint of reflection from the stainless wire was noticed. This was hidden with a dab of grout-coloured acrylic paint applied with a toothpick. Three thousand such fasteners were used on the project.
