The Consolidation  
of  
Plain Face Plaster  
at  
Notre Dame Cathedral  
Ottawa, Canada

by  
Historic Plaster Conservation Services Limited  
[www.HistoricPlaster.com](http://www.HistoricPlaster.com)

Notre Dame Cathedral was built over 50 years between 1830 and 1880. Only the front façade and lower side walls are of solid masonry construction. The interior is heavy timber framing covered with wood lath and plaster. Ornament is hollow slip-cast plaster of Paris.

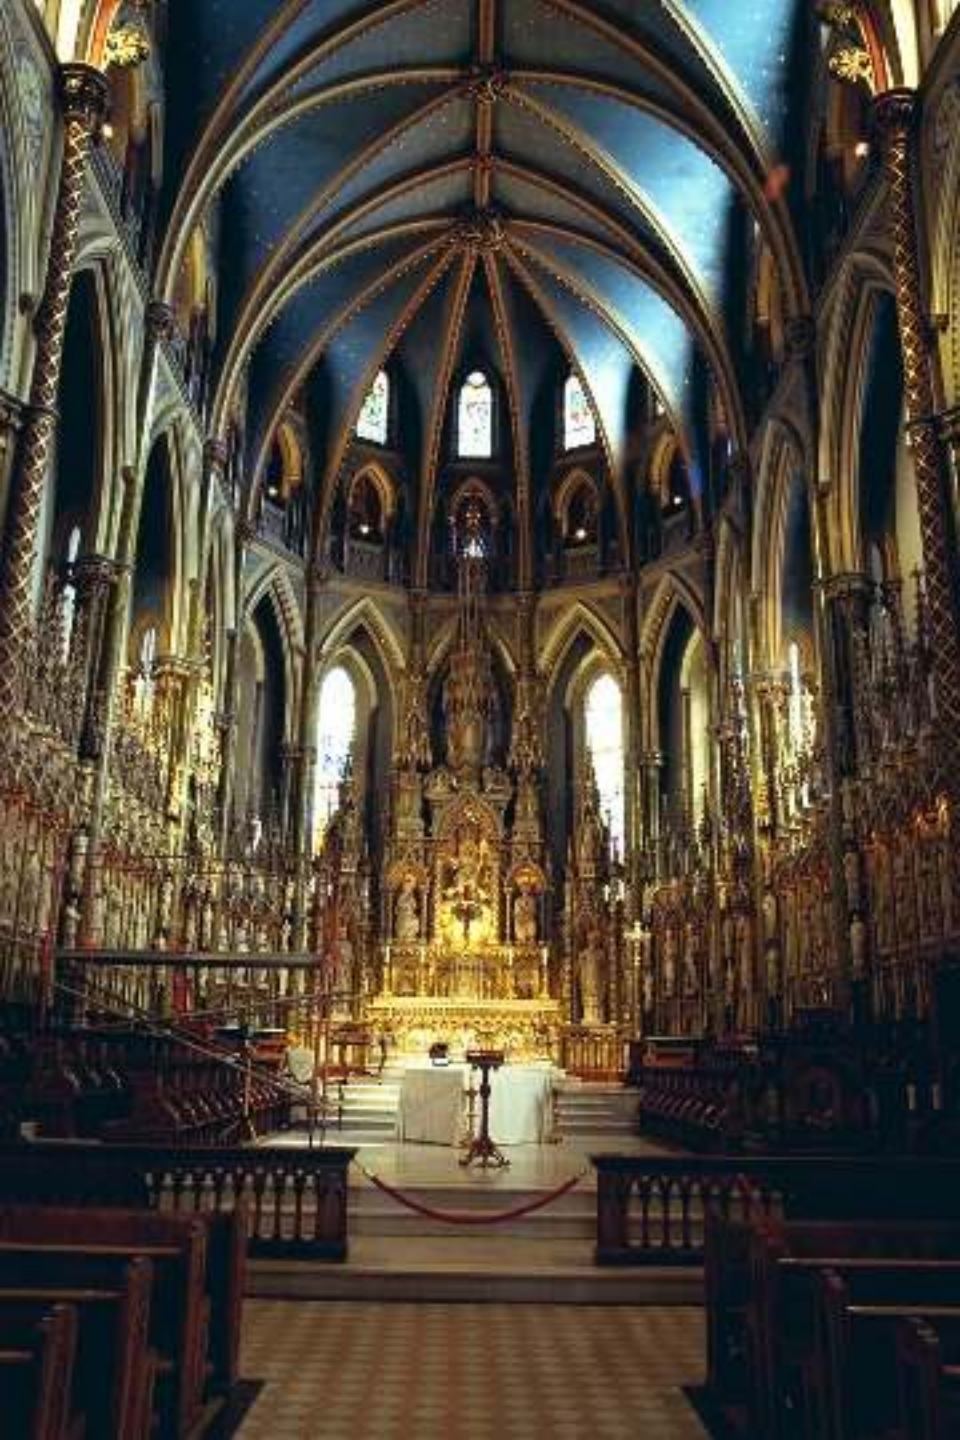
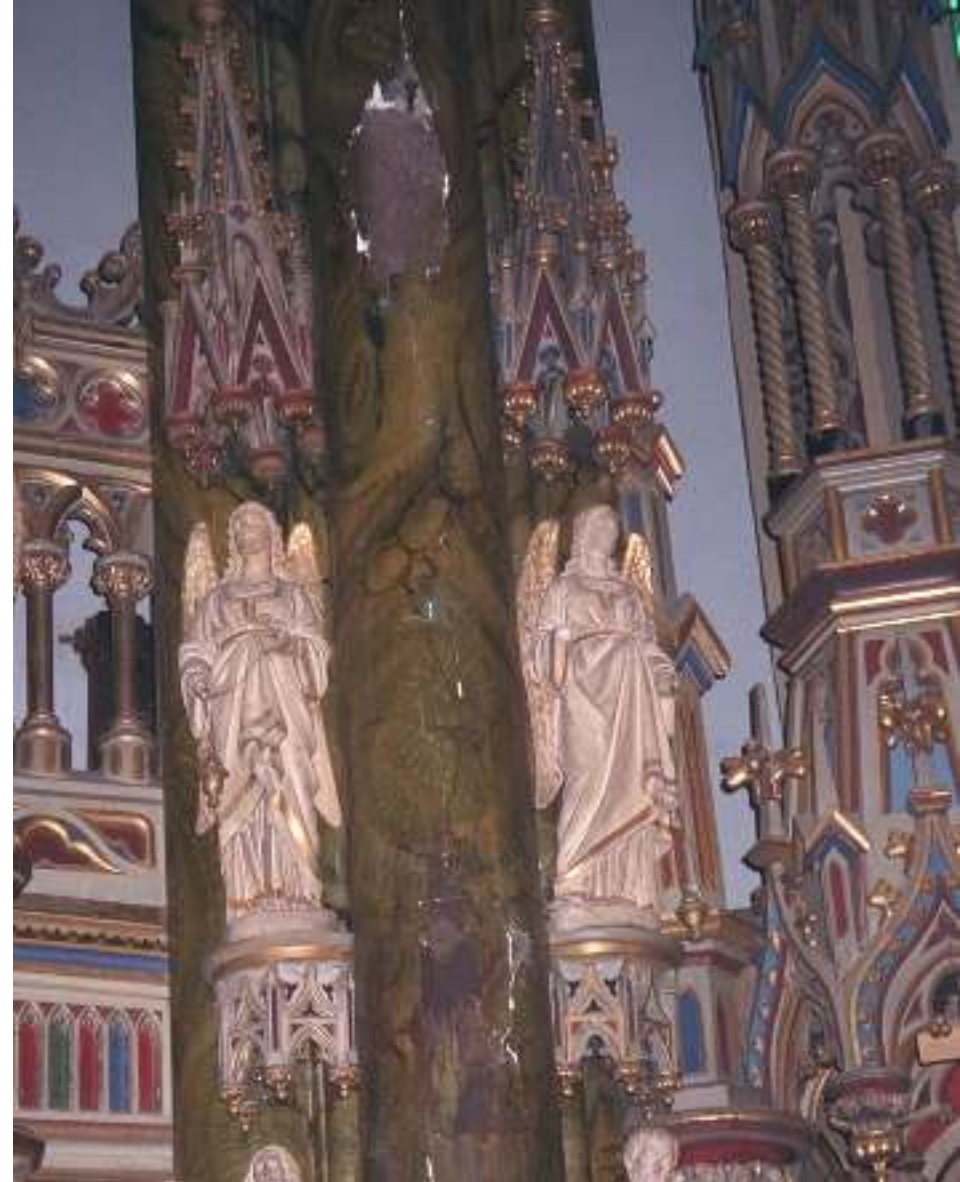
Faux marble finish on plaster columns

Faux finishes were done in a naive and exuberant style probably by artisans who had never seen the real thing.

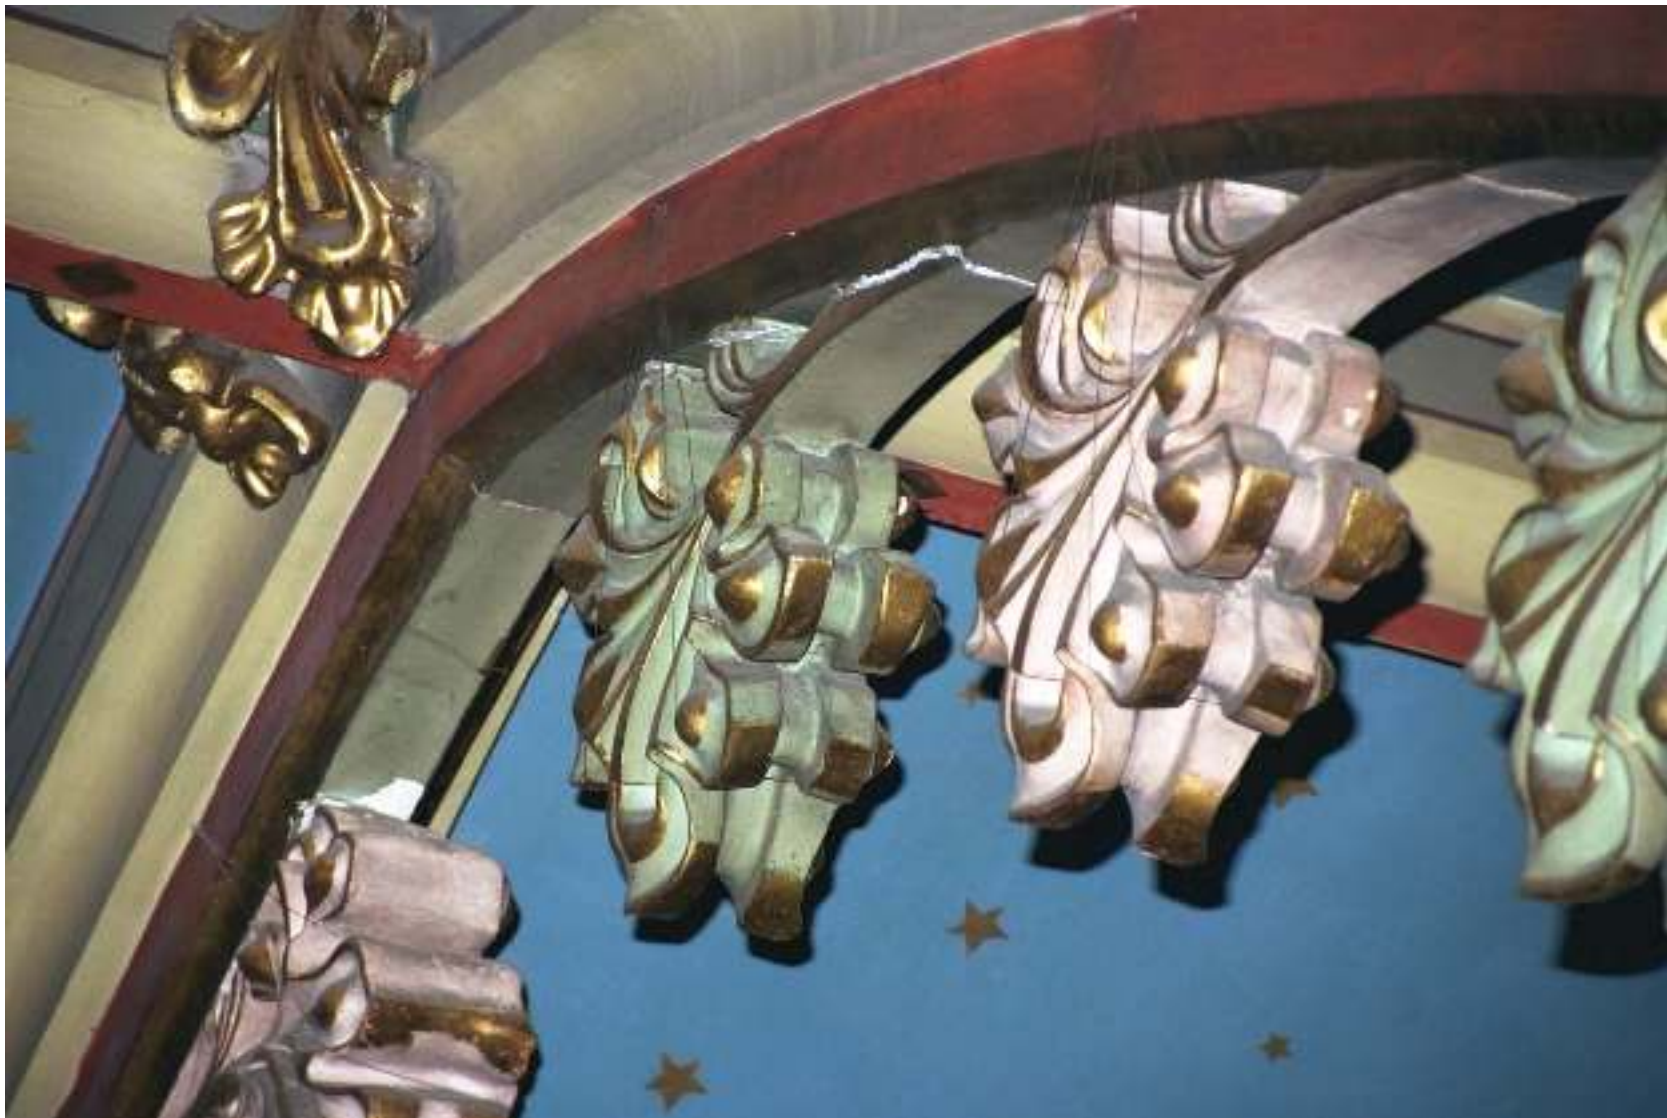
# PLASTER RIBS CRISSCROSS THE CEILING

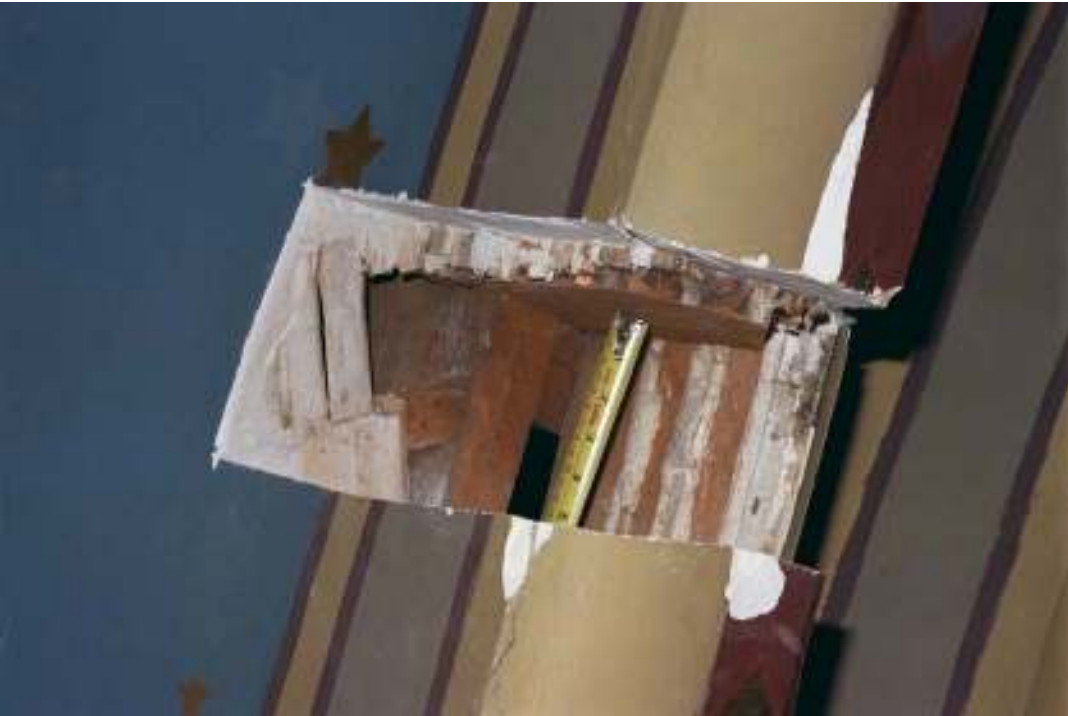
A RIB CUT OPEN FOR  
INVESTIGATION

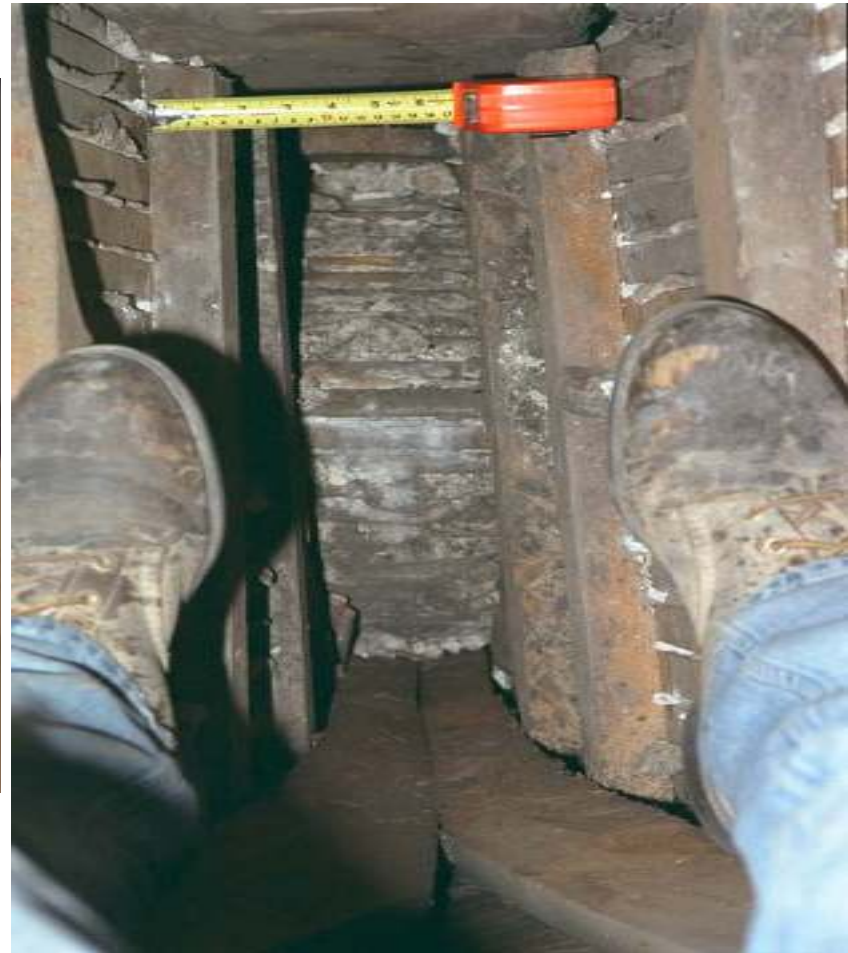
SEEN FROM ABOVE

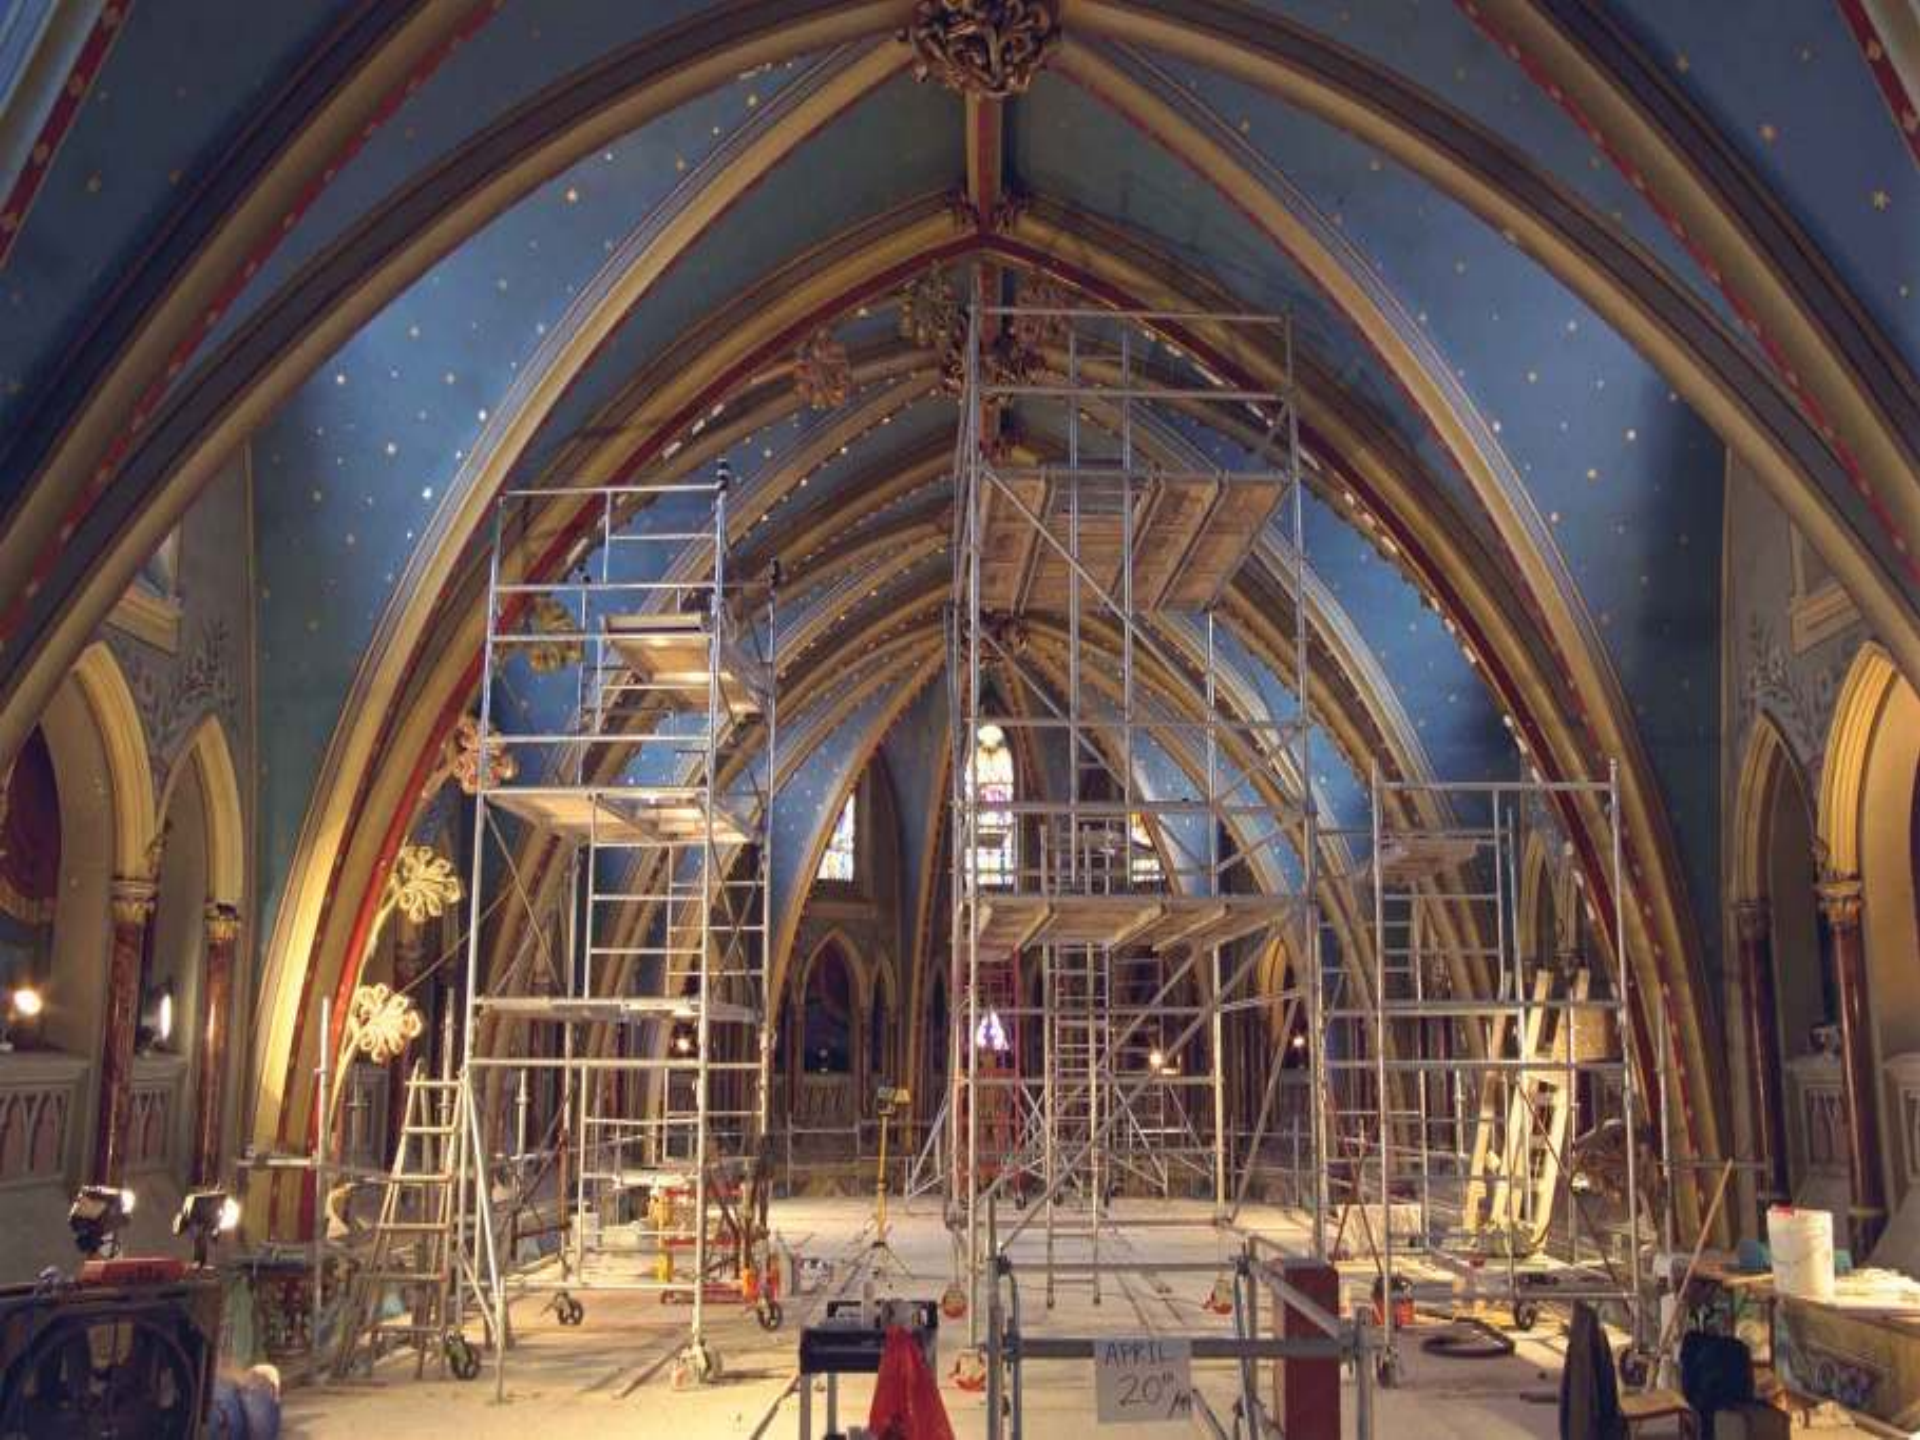
Sawn wood lath and lime based plaster covers the vast area of the ceiling.

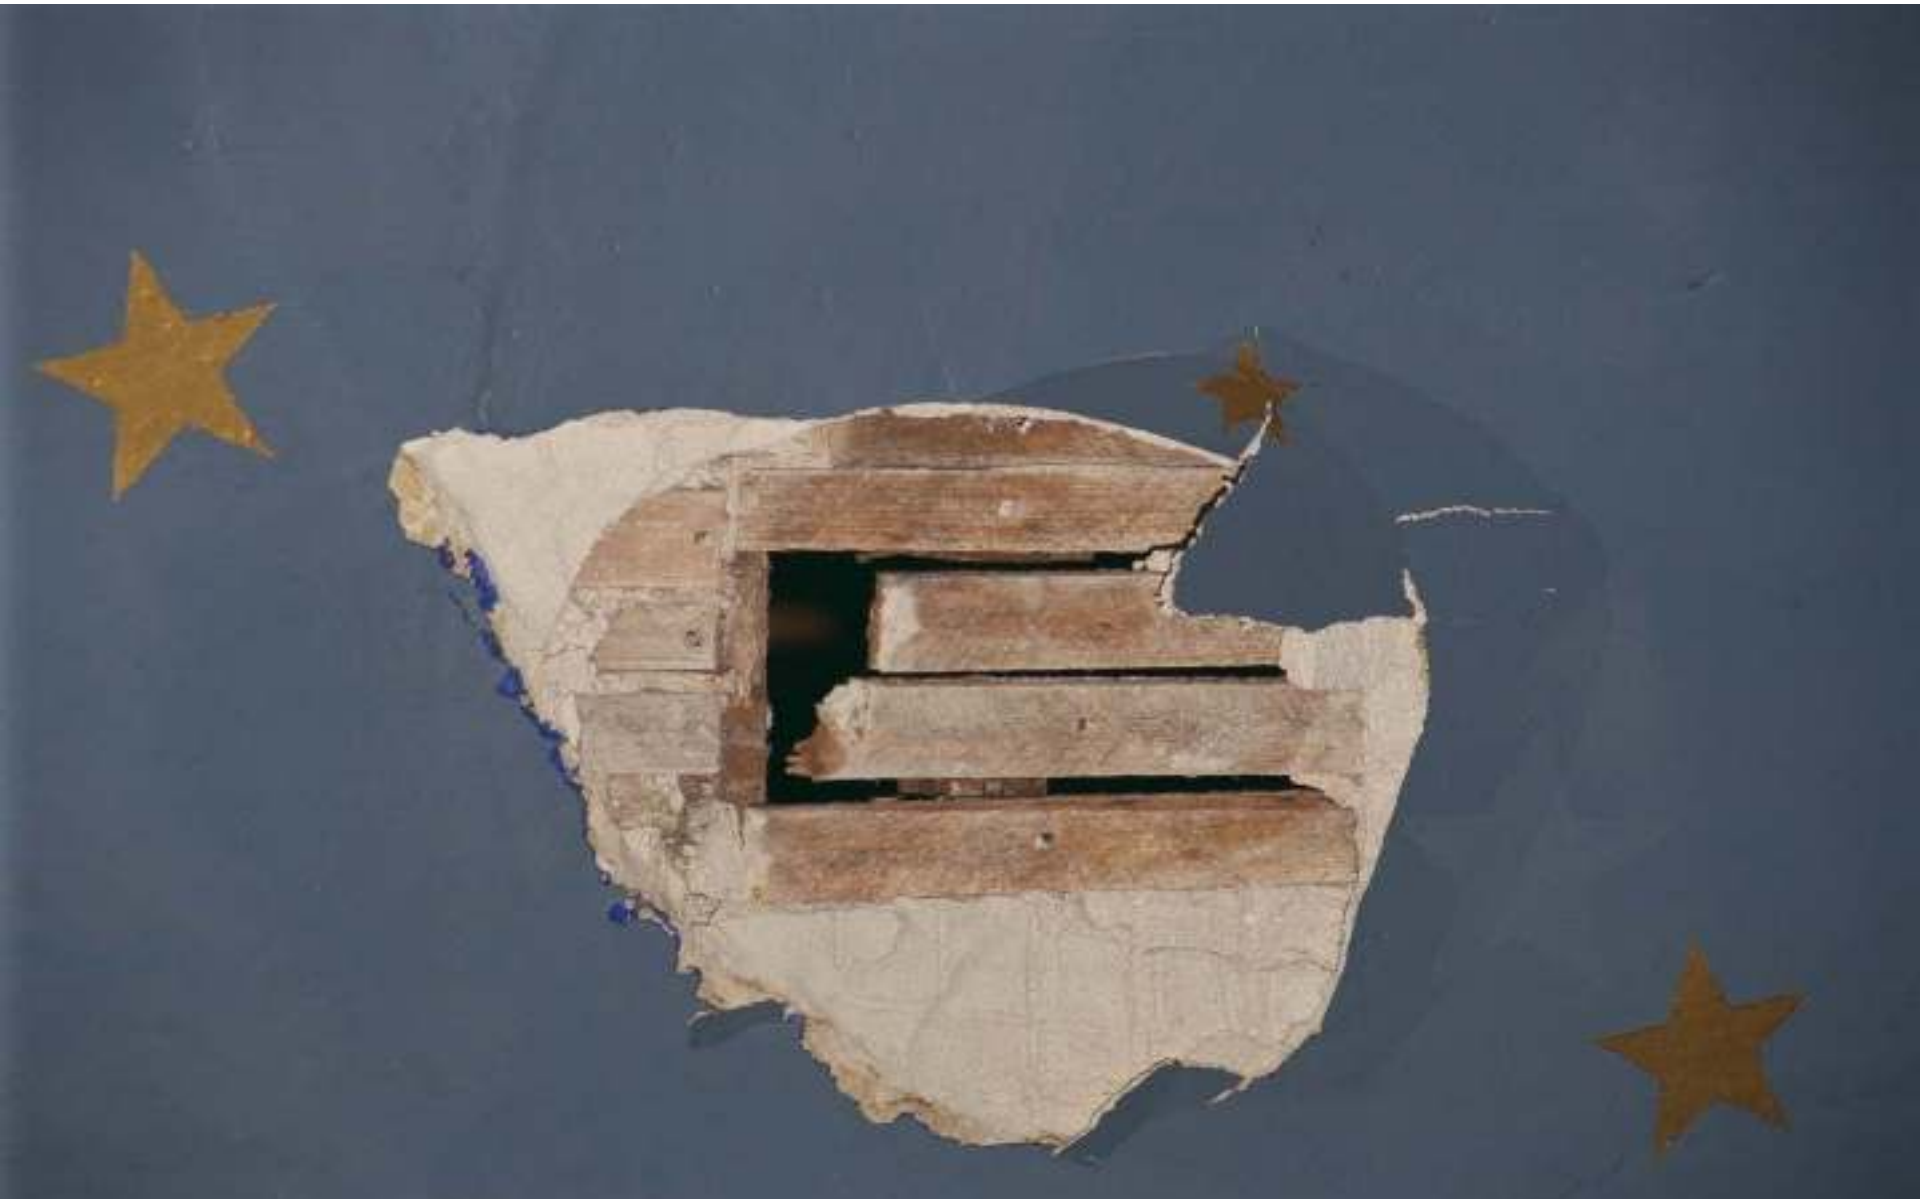
# Typical Cross-section of a Wood Lath Plaster Ceiling

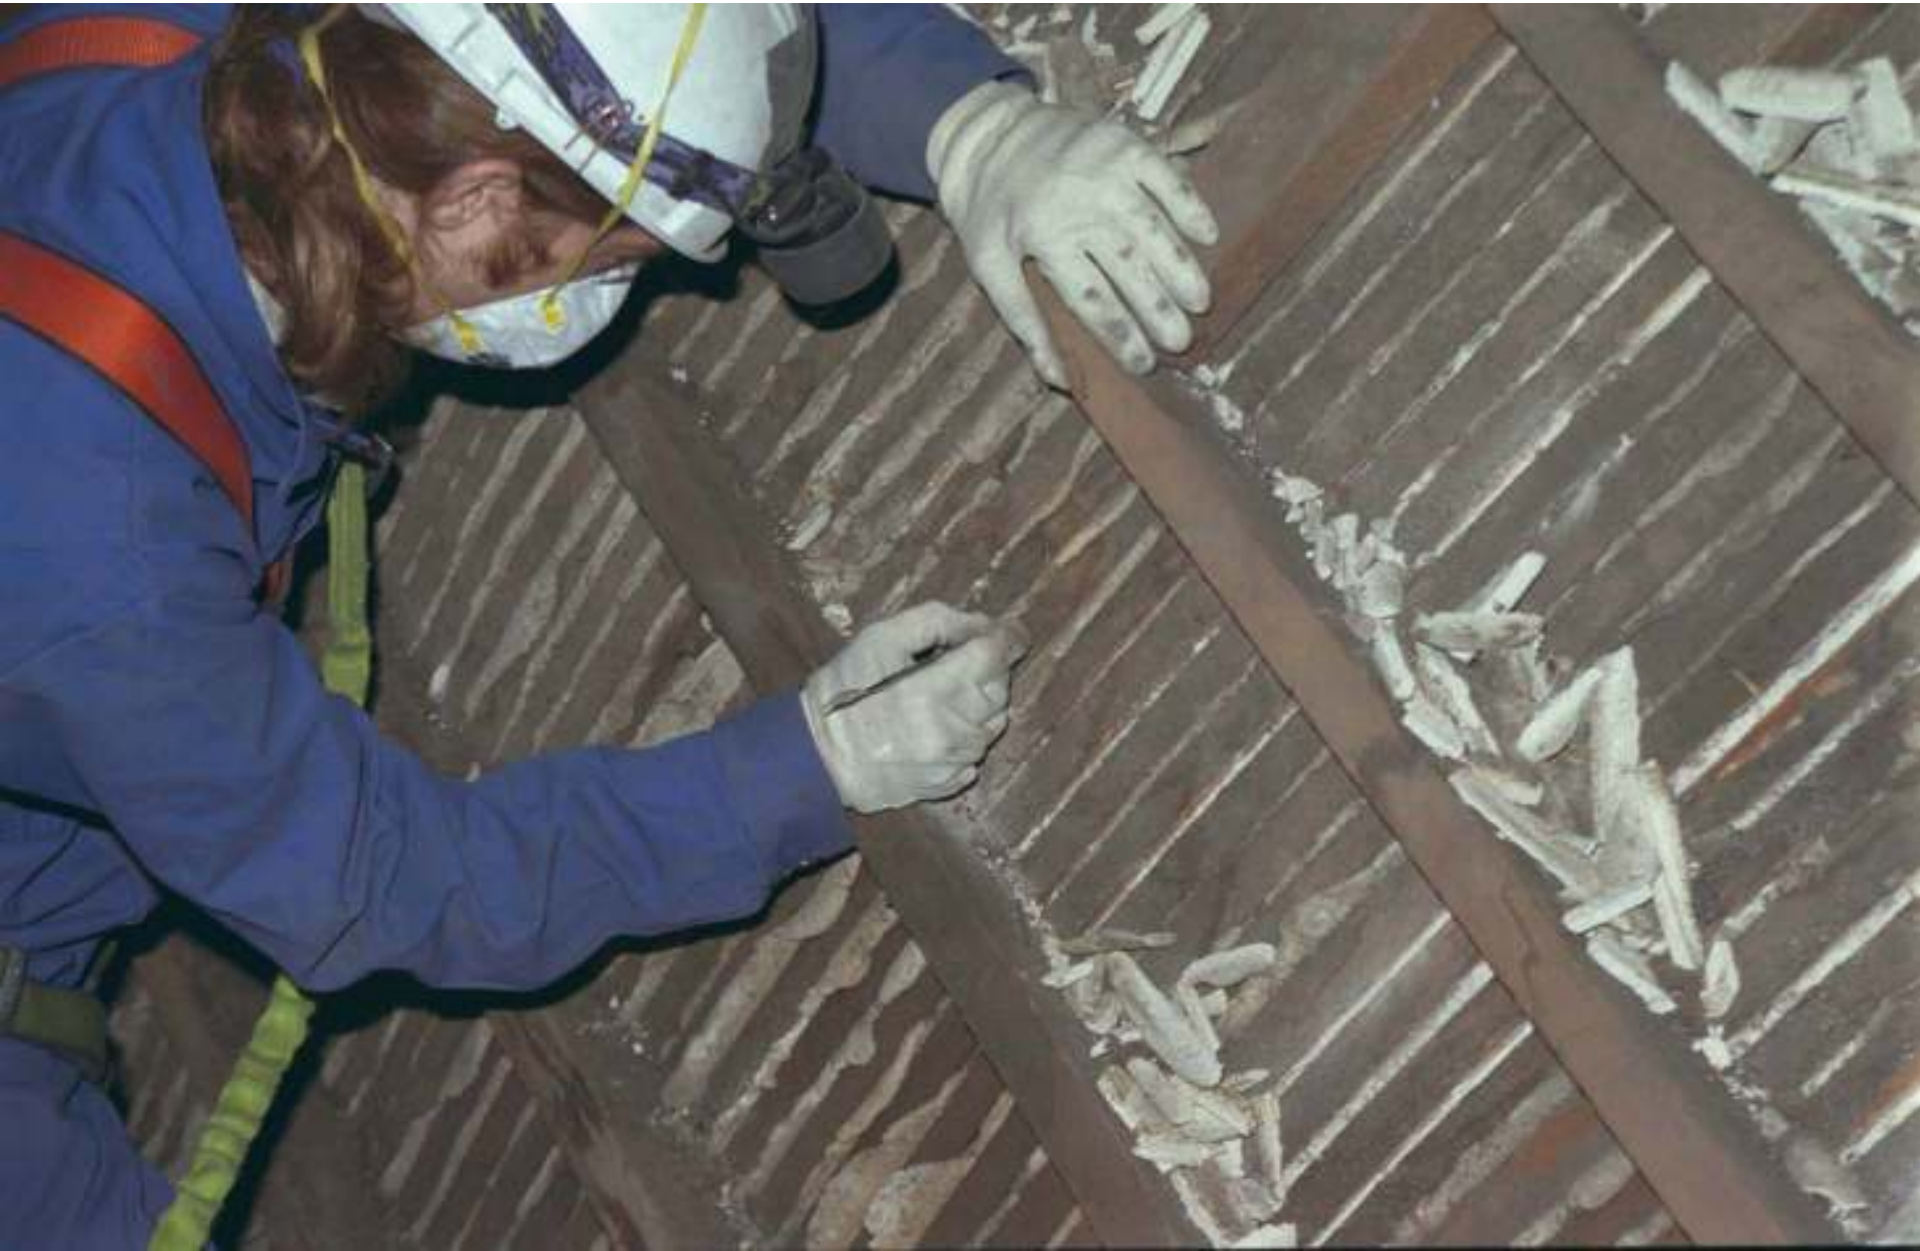
NAVE ATTIC  
SAMPLE  
AREA  
# 8  
INPS DATA RECORD  
NOTRE DAME  
CATHEDRAL

After a thorough vacuum cleaning technicians test the individual plaster keys by tugging gently on the lugs.

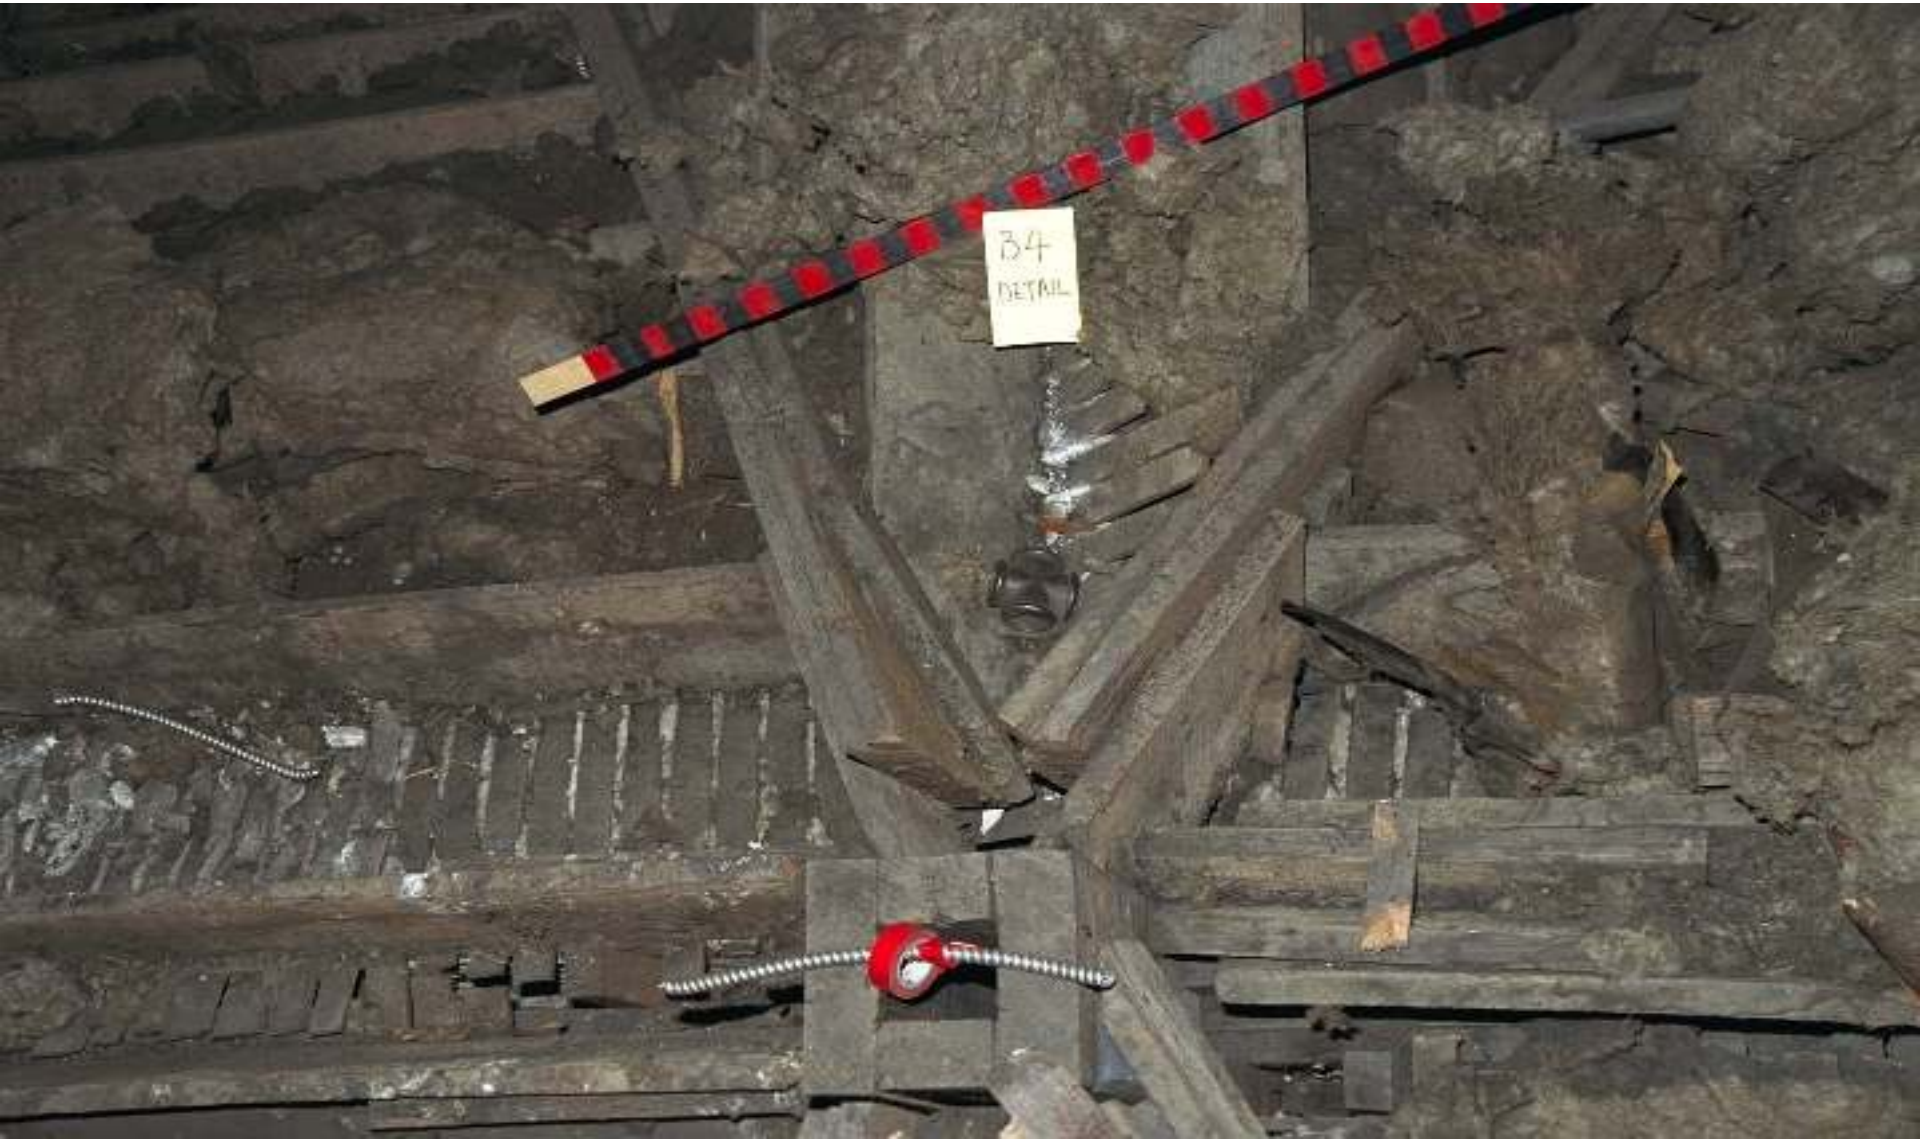
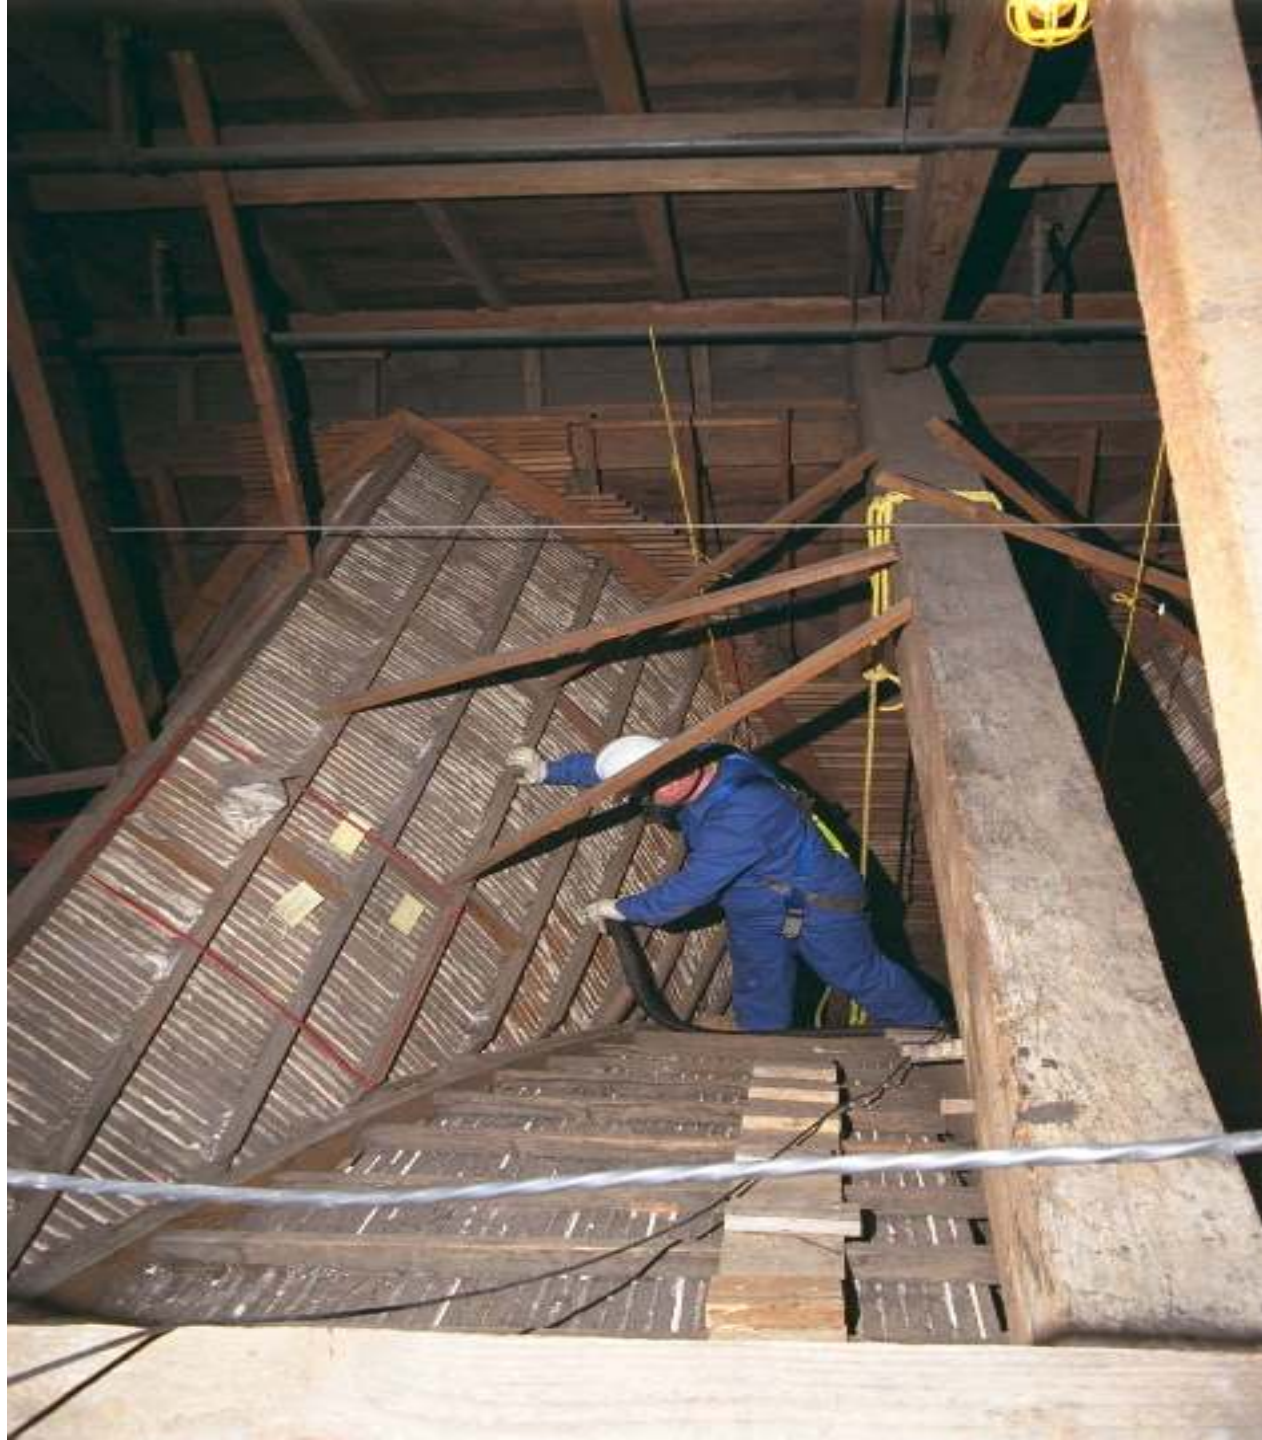
When the coal fired heating system was removed back in the 1960's, the badly deteriorated chimneys were cut down to below roof level. All the soot from that demolition was evenly spread throughout the attic. All of it, and all the other junk that accumulates over a century had to be removed prior to consolidation of the plaster ceilings.

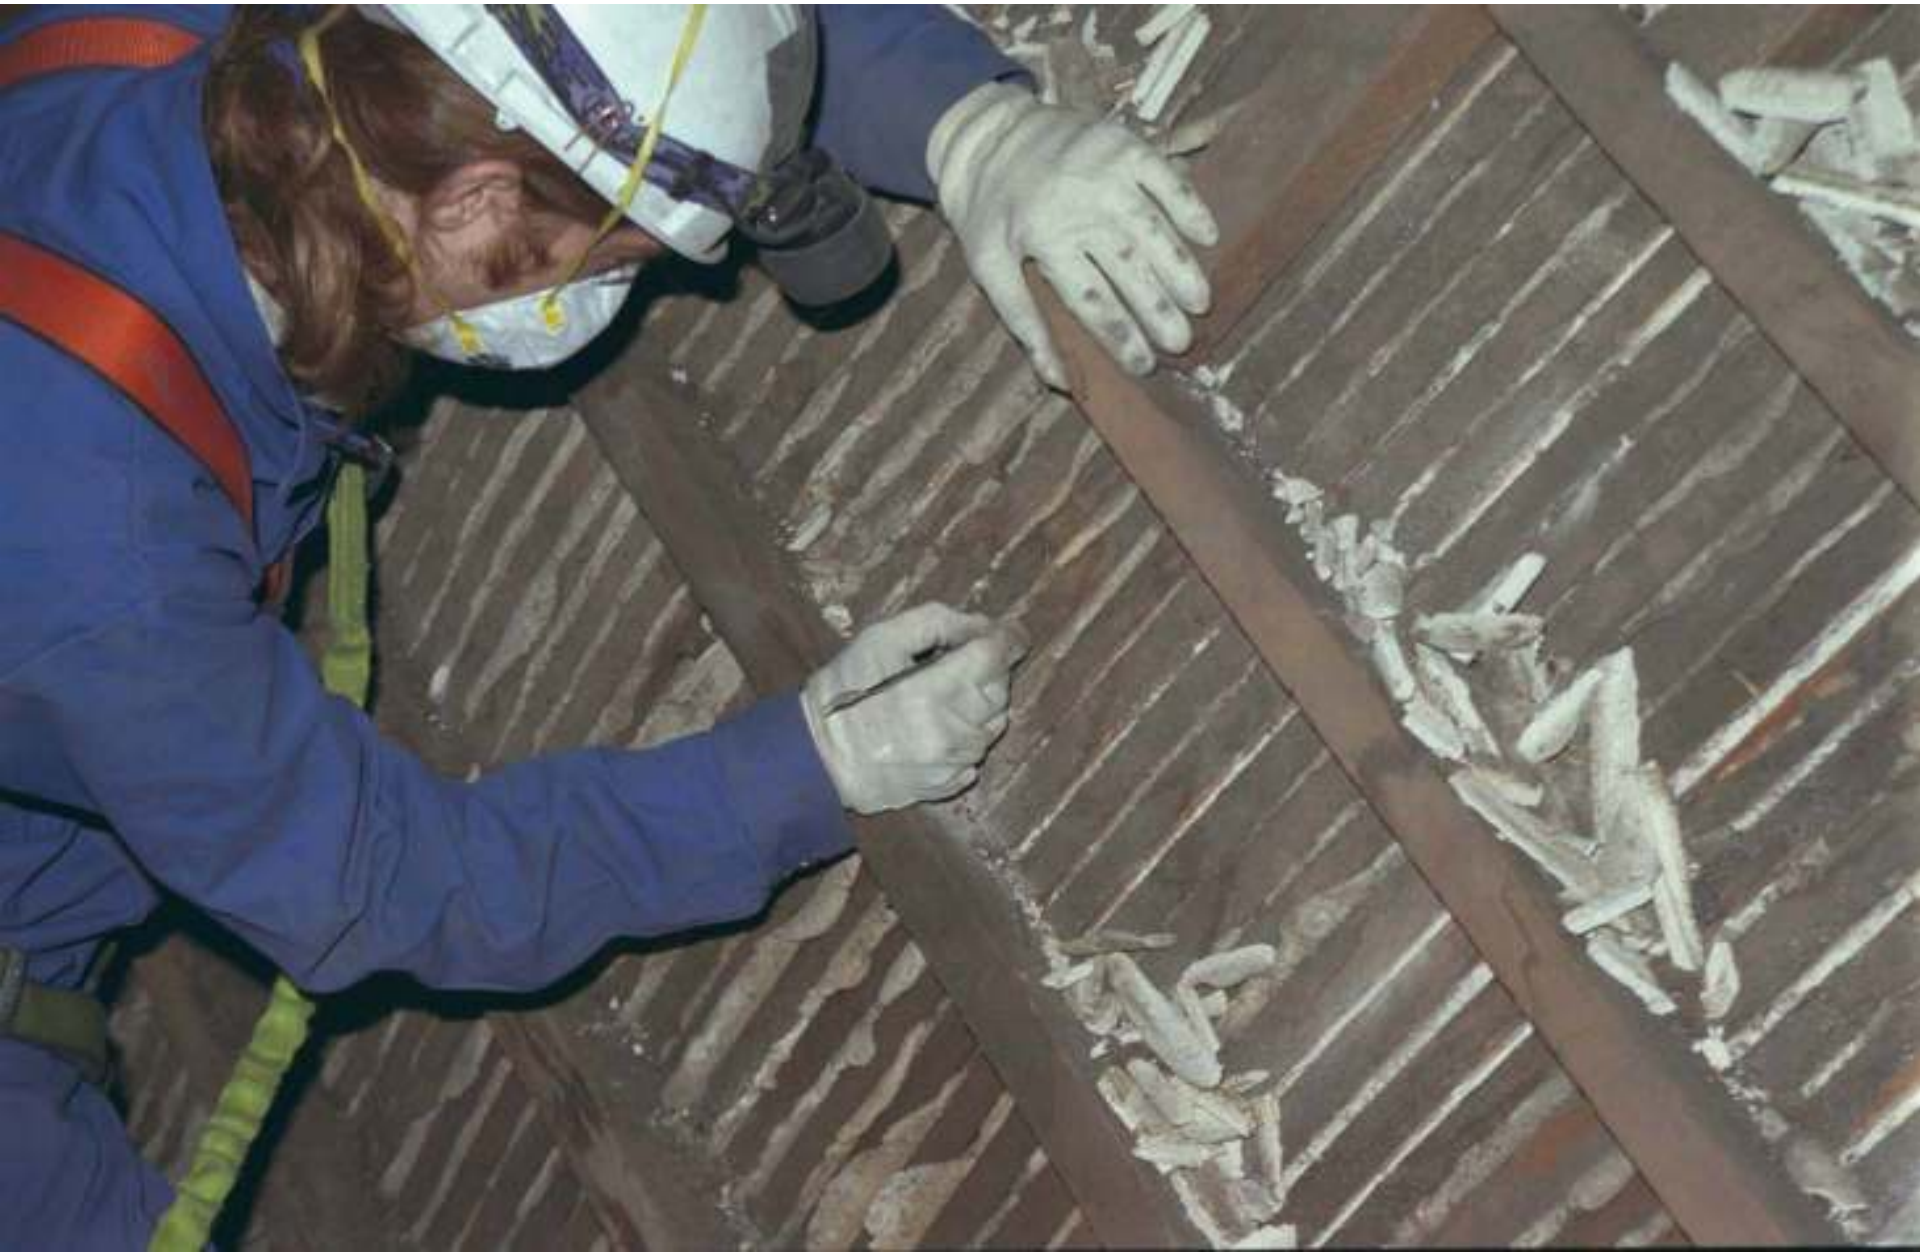
After a thorough vacuum cleaning technicians test the individual plaster keys by tugging gently on the lugs.

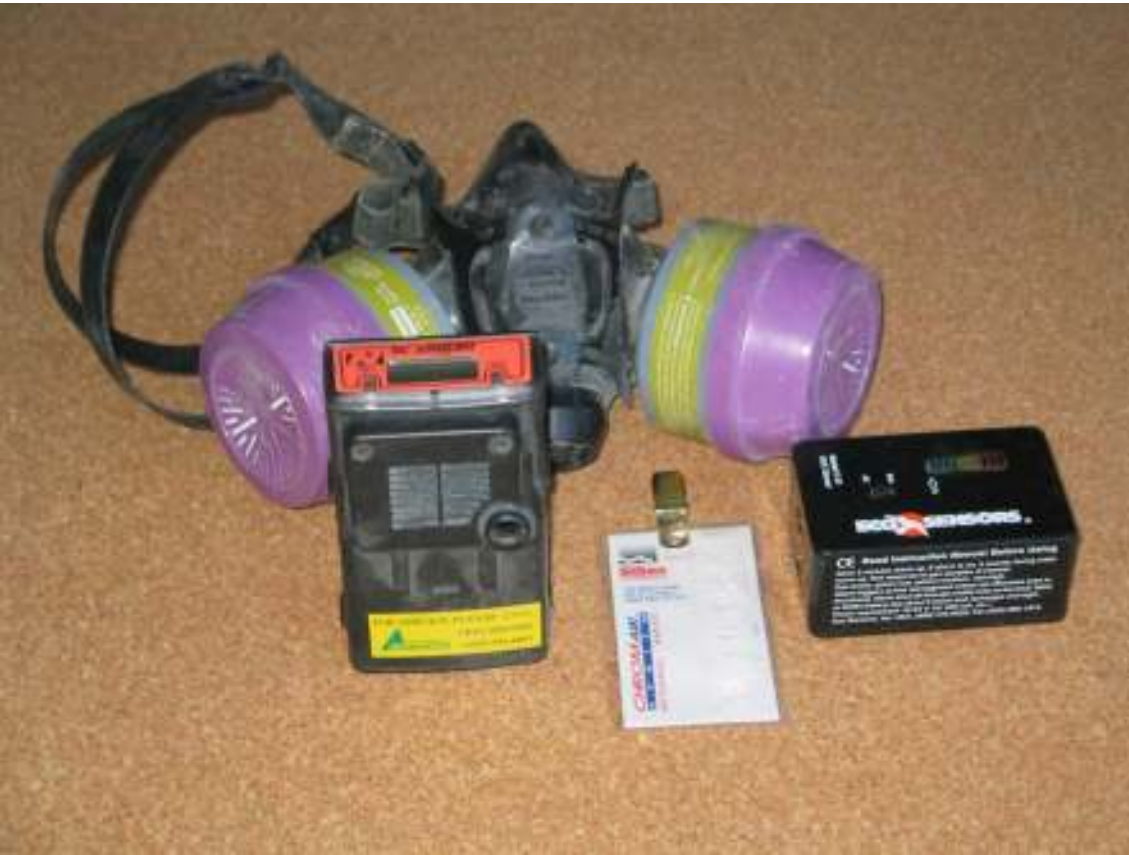
# ESSENTIAL SAFETY GEAR

- Chromair System® Personal Exposure Badges for Methanol
- Respirator with Organic Vapour and dust filters
- Personal Single Gas Monitor worn on belt
- VOC sensors at various location on site
