# Plaster Conservation Report Gould Memorial Library, Bronx Community College

Prepared by  
Historic Plaster Conservation Services  
Limited

August 2002.

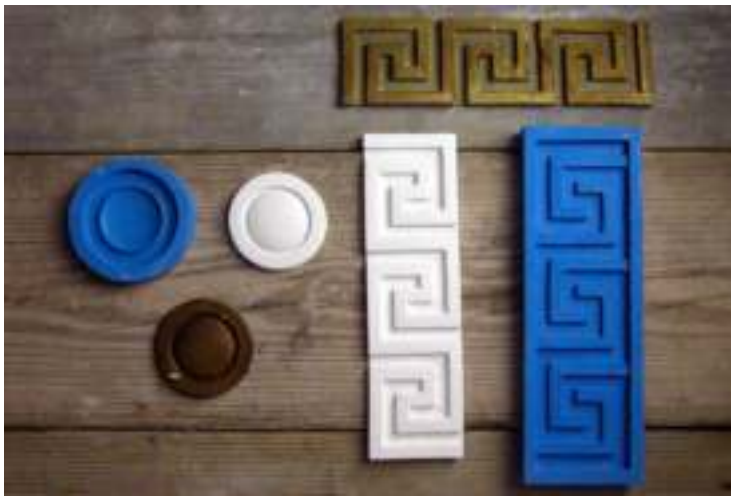
Prior to cleaning, several key strips were dangling from the ceiling and several more fell off in our hands with the slightest touch. Past attempts had been made to conceal some of the missing decorations by painting the bare white plaster a dirty green color. We replaced all the missing or severely damaged ornaments with accurate replicas.

Rubber molds were made to produce the replica parts. Replicas were cast with plaster of Paris and a fabric strip was set into the back of the parts similar to the originals. The fabric makes the thin plaster parts more durable.

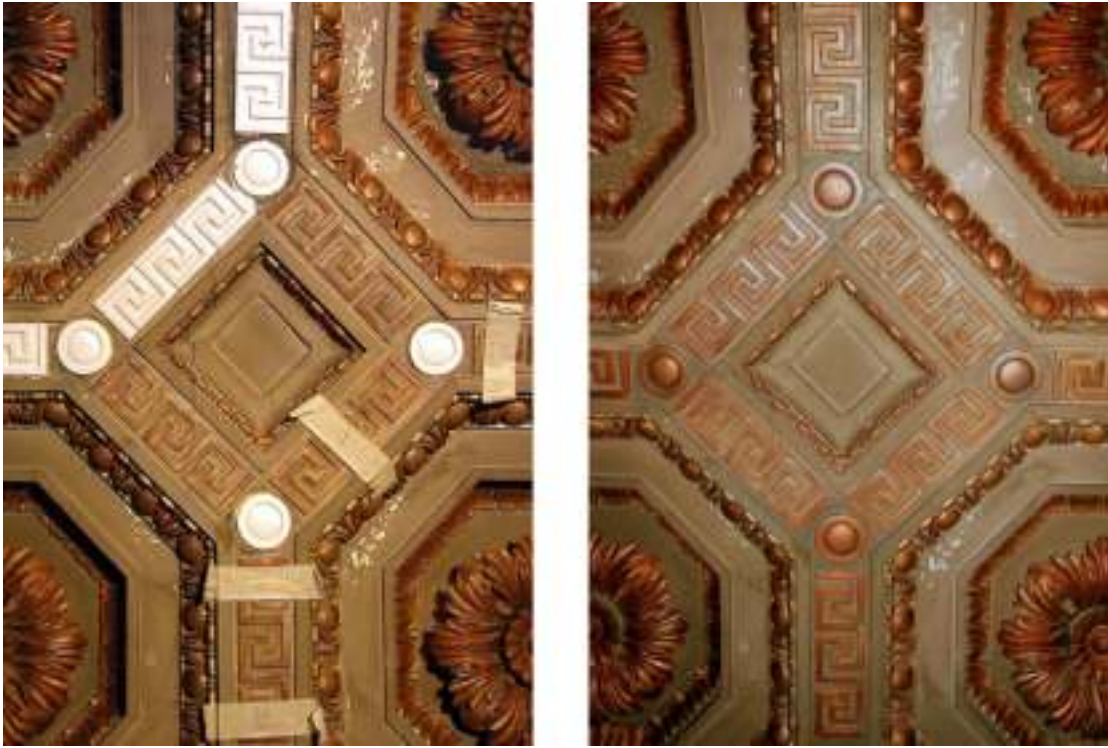
These photos show the original and replica ornaments before and after painting. The rubber molds used to make the replicas were cast from original ornaments, and once painted, the replicas became difficult to tell from the originals, even at arm's length. These photographs were taken before the beige background had been painted.

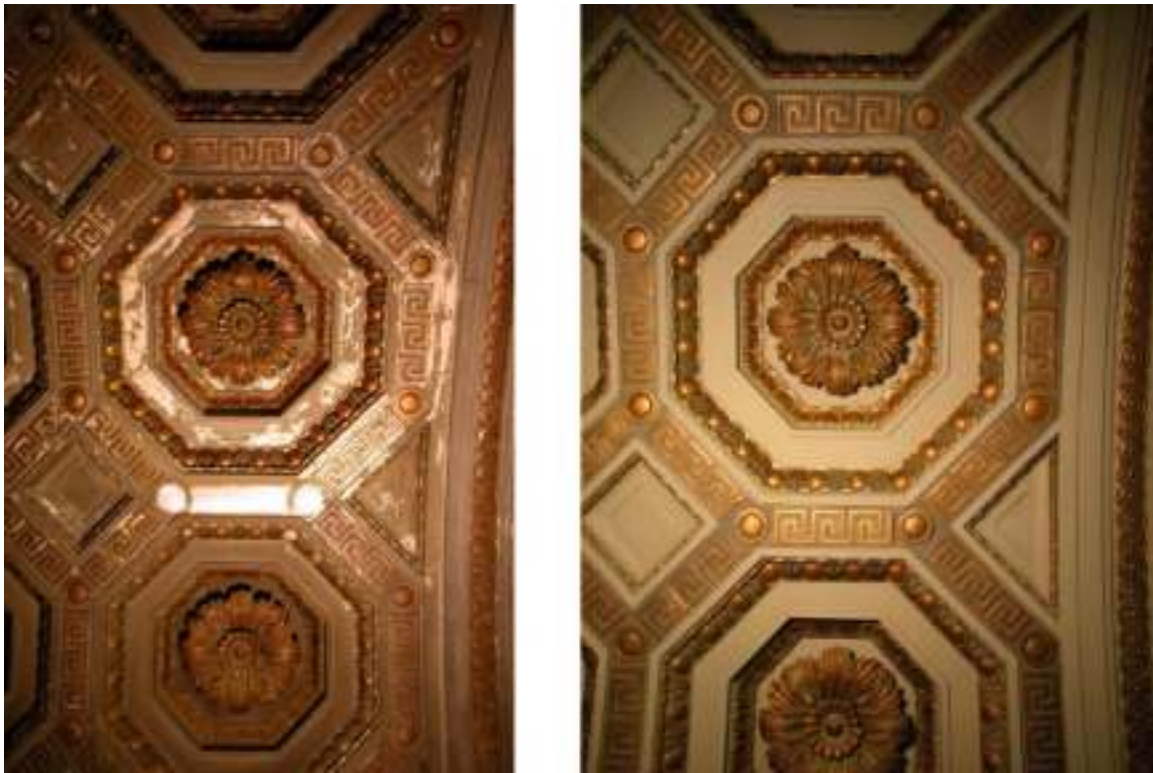
Before and after painting.

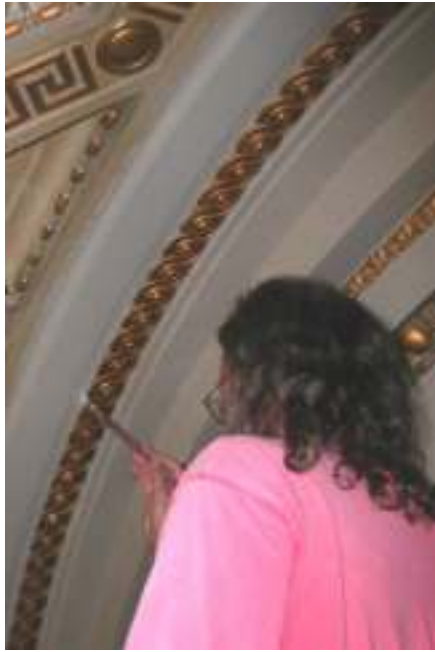
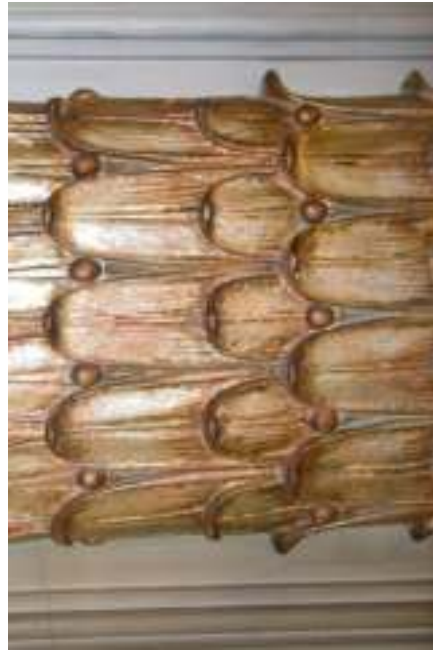
Cutting in with beige around the gold ornamentation was done in one coat, as the original had been. The top of the photograph on the right shows an area that has been repainted, while the bottom is the original coat. At close inspection, brush marks are visible in both. Beyond six feet they both appear to be a uniformly opaque coat.

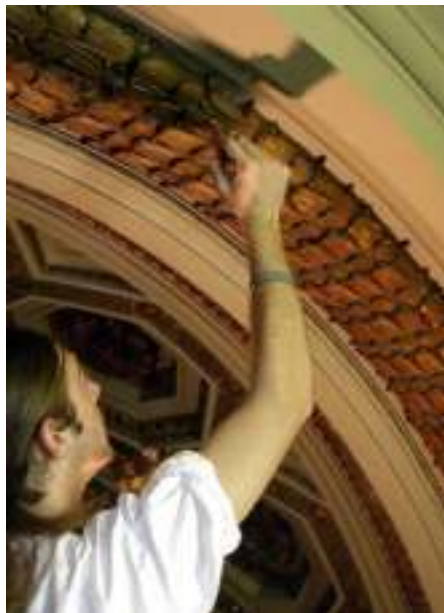
Most of the gold ornamentation in the lower entry hall needed touching up. Paint was mixed in small batches, or mixed while being applied, because of the great variability of the original color.

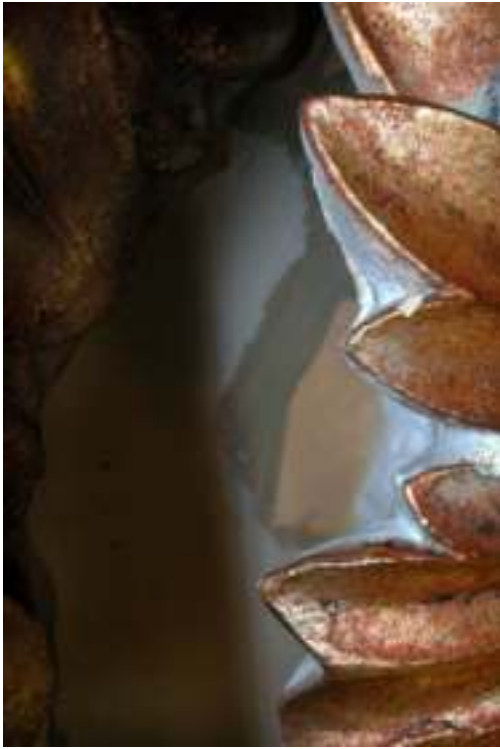
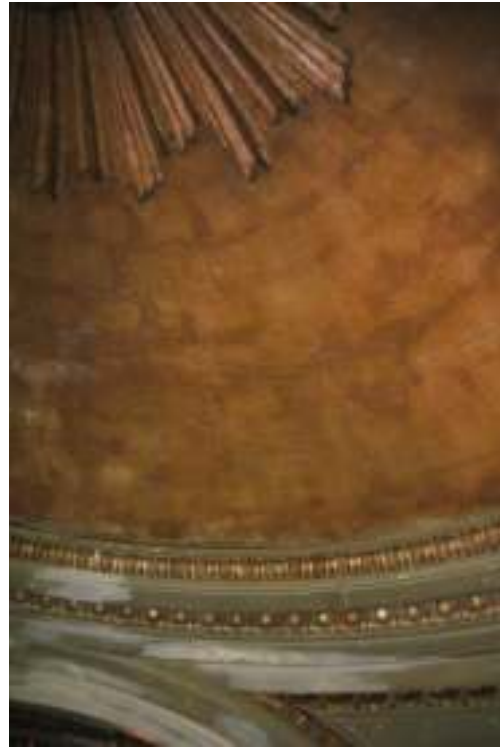
The photograph on the left shows an area behind a rosette in which some of the yellow undercoat did not get painted over by the original painters. This was very useful evidence in determining how to recreate the finish on the domes. Areas like this, hidden from view from the floor and with original finishes, were left as a record of what had been done to this building. Our paint coat leaves visible some original background with the undercoat.

The photograph on the right shows a faint pattern of square patches on the lower dome. This tells us the textured finish coat of the dome was applied in a jabbing motion with a large square stippling brush.

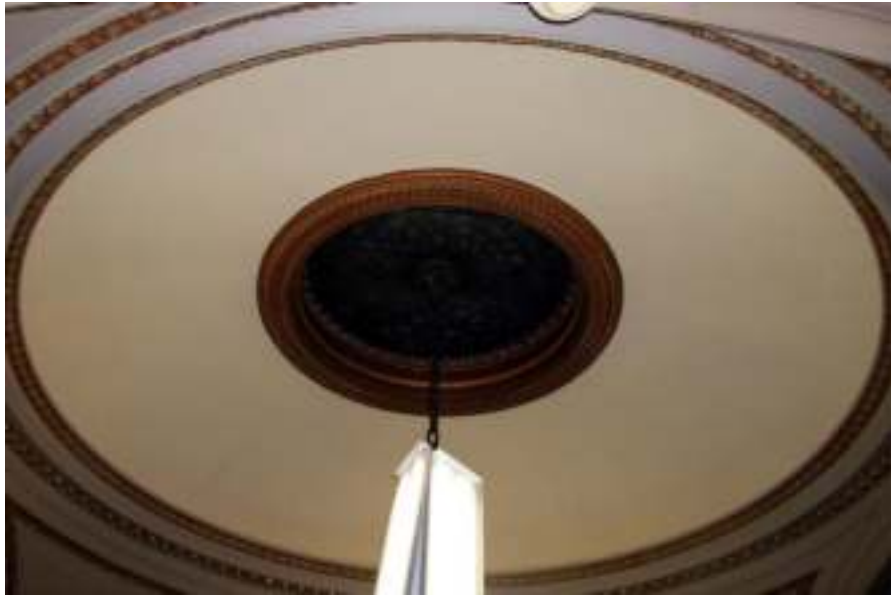
The upper dome with a yellow undercoat applied. The original finish of the ribbon band around the oculus was in perfect condition, and repainting it was unwarranted.

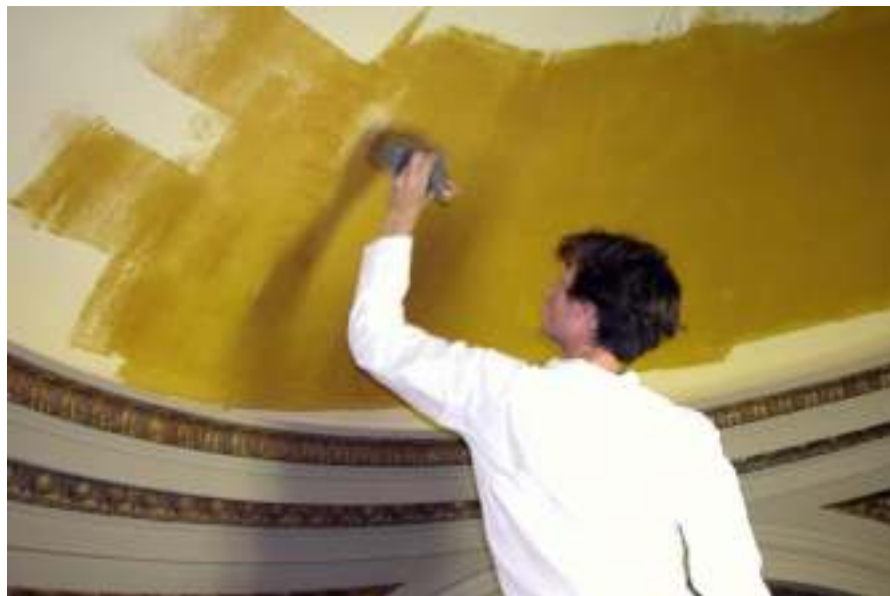
The first stippled coat is being applied in this photograph. We used a square brush about the same size as was used originally, and applied the paint in a jabbing motion.

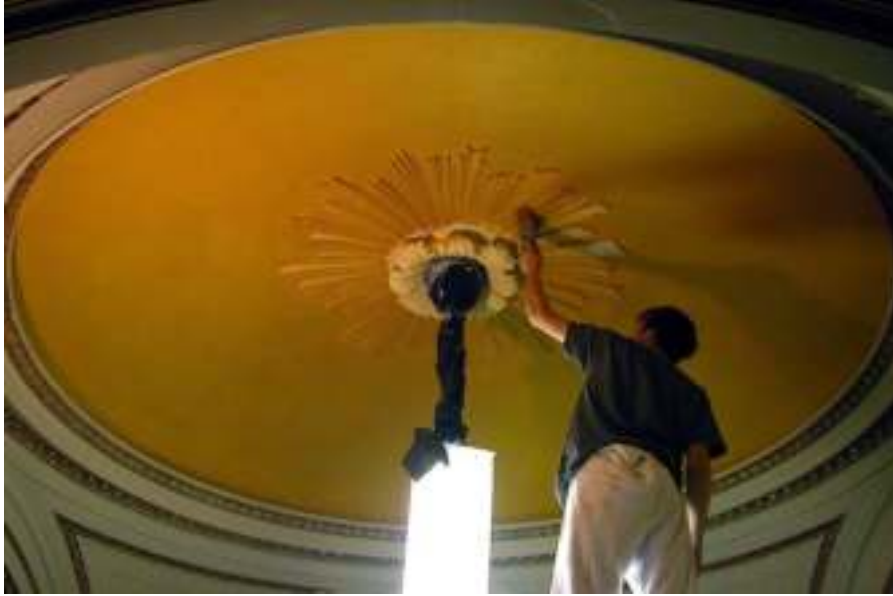
The final coat is applied to the sunburst of the lower dome. The sunburst was very soiled and there was much more paint missing than on the ribbon band of the upper dome. Repainting was necessary.

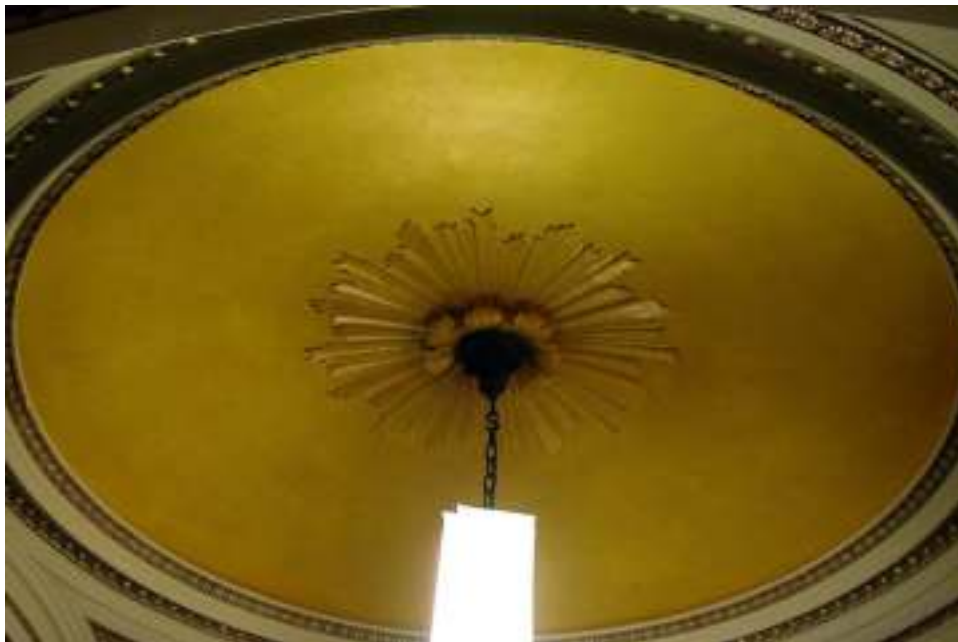
The finished lower dome.

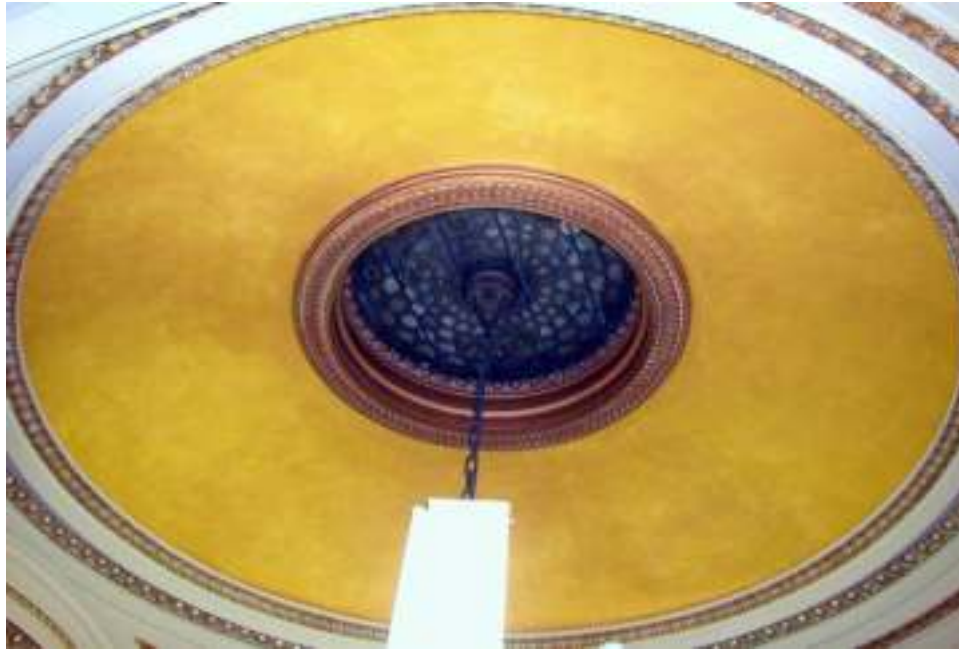
The finished upper dome.
