Notre Dame Cathedral
Ottawa, Ontario

Plaster Conservation at Notre Dame Cathedral

Report compiled by

Rod Stewart
Historic Plaster Conservation Services Limited
26 Barrett Street,
Port Hope, Ontario L1A 1M7

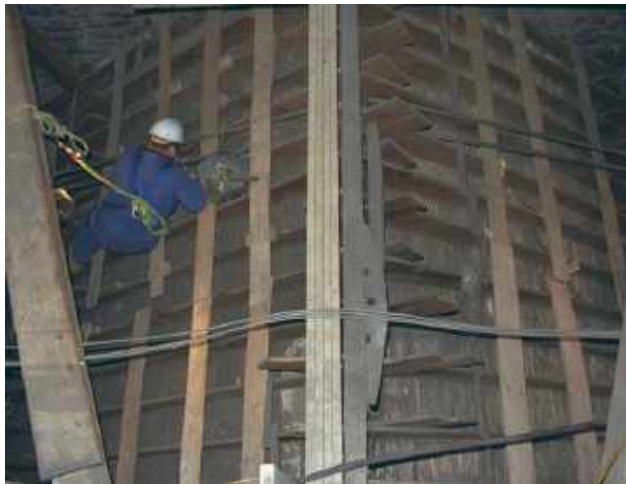
Special rigging was required to permit the safe access of workers over the entire attic surface. Deep ravines in the attic correspond to the soaring arches visible in the Cathedral below.

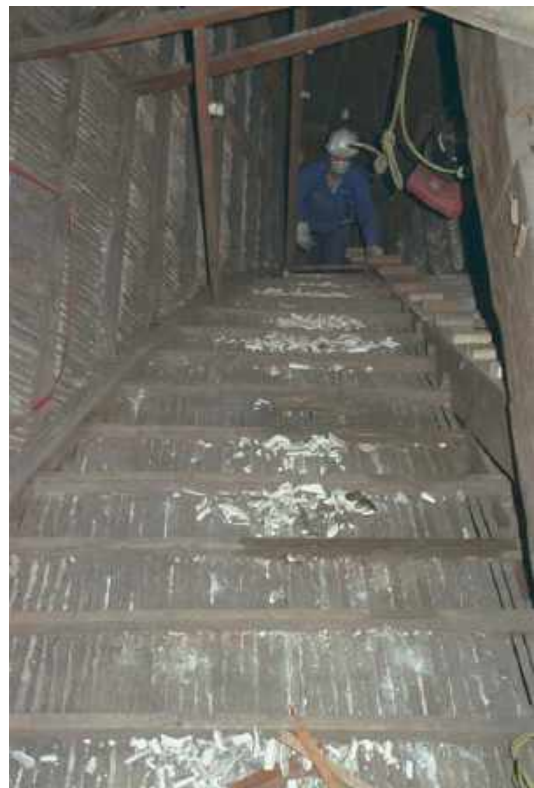
Each plaster key was hand tested, and where found loose, removed. Further vacuum cleaning left the upper surface of wood lath and plaster dust-free and ready to accept the consolidants.

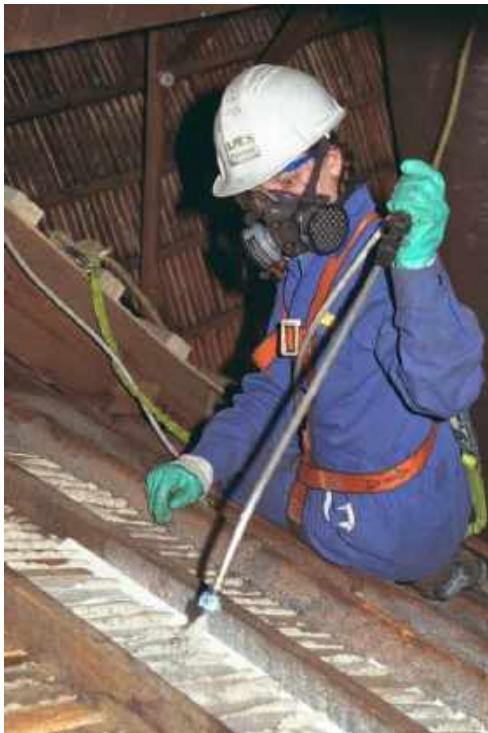
A dilute mixture of acrylic resin and methanol (15% resin) was spray applied to the surface with agricultural backpack sprayers. The methanol, acting as a surfactant, wets the surface and allows the resin to penetrate deep into the plaster. Three applications of diluted resin (15%, 30%, and 50%) were done, finishing with an undiluted final coating of resin. In this process, the methanol evaporates into the attic

atmosphere and is exhausted by the fans. This leaves the resin deposited in the plaster. The acrylic resin used is 46% water, and 54% resin solids. After the evaporation of the methanol, the resin coalesces, with its water content evaporating to be exhausted outside the building.

The condition of the plaster after this stage is much improved. It is a uniformly strong, coherent material - consolidated - where before it had been crumbling and of very uncertain and diverse quality.

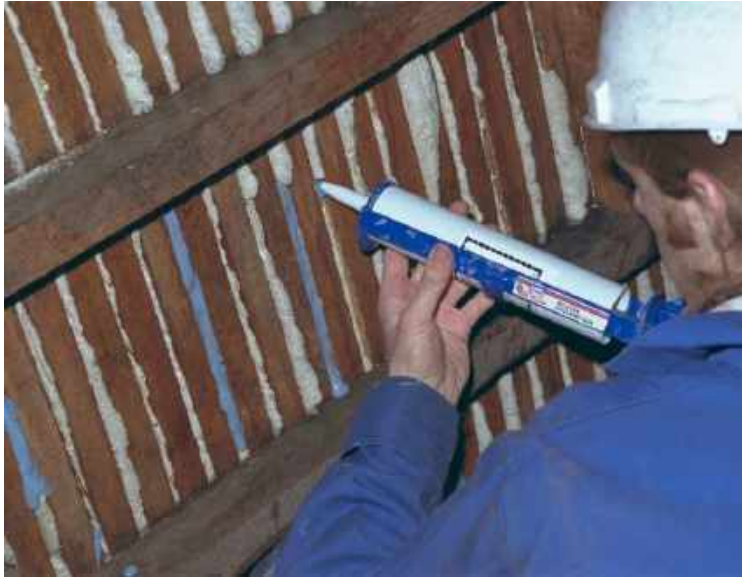
Following a period of curing and evaporation, the missing plaster keys are replaced. A thick gelatinous adhesive was made from the same acrylic resin and mixed with lime, fluid petroleum coke and micro-balloons. For application, the adhesive was loaded into 300 ml caulking tubes. 750 tubes of this material were used on the cathedral plaster conservation.

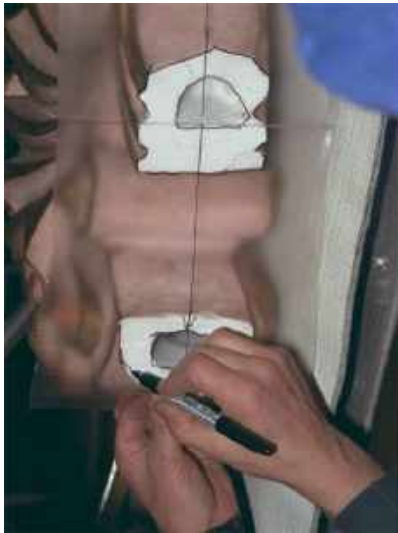
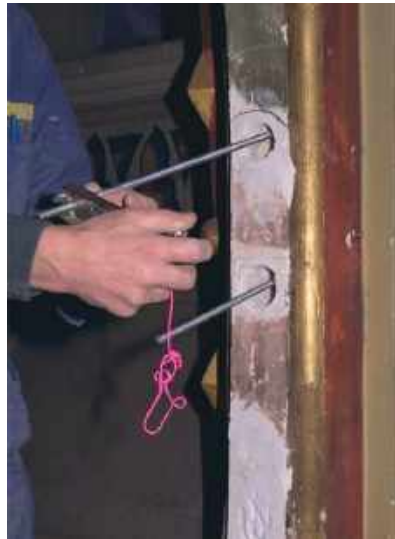
Initial inspection indicated up to seven of the crockets had broken their plaster connection and their attachment was dependent on the fine metal clips and the web of light piano wire loosely slung under them and fastened to the outsides of the rib. It was evident that this wire was a later addition that tried to address the danger of these elements falling to the floor. Clearly, there was a safety concern that had to be addressed in any conservation scheme.

Matching holes were enlarged within the attachment "footprint" surface of the crockets, so that when the crocket was in place, there would be a pair of 1 1/2" holes connecting the interior of the crocket with the interior of the rib.

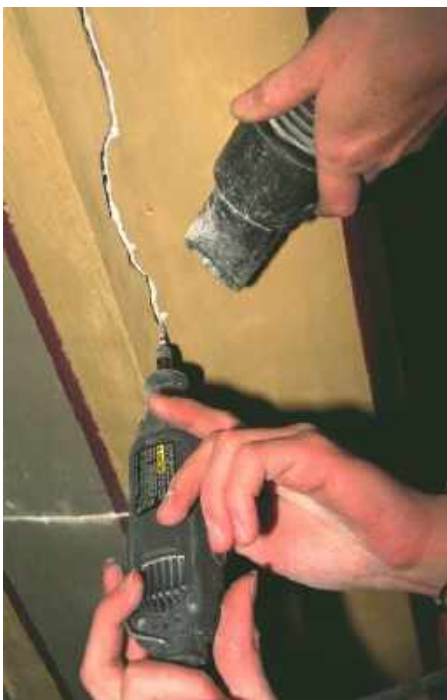
In some cases the vibrating element was removed during this process. These was usually where the vibration seemed to emanate from the actual original connection of element to surface. Often the intended connection surface was covered in grime and dust, indicating that the joint had not been made properly in the first place, or the damage had occurred long ago.

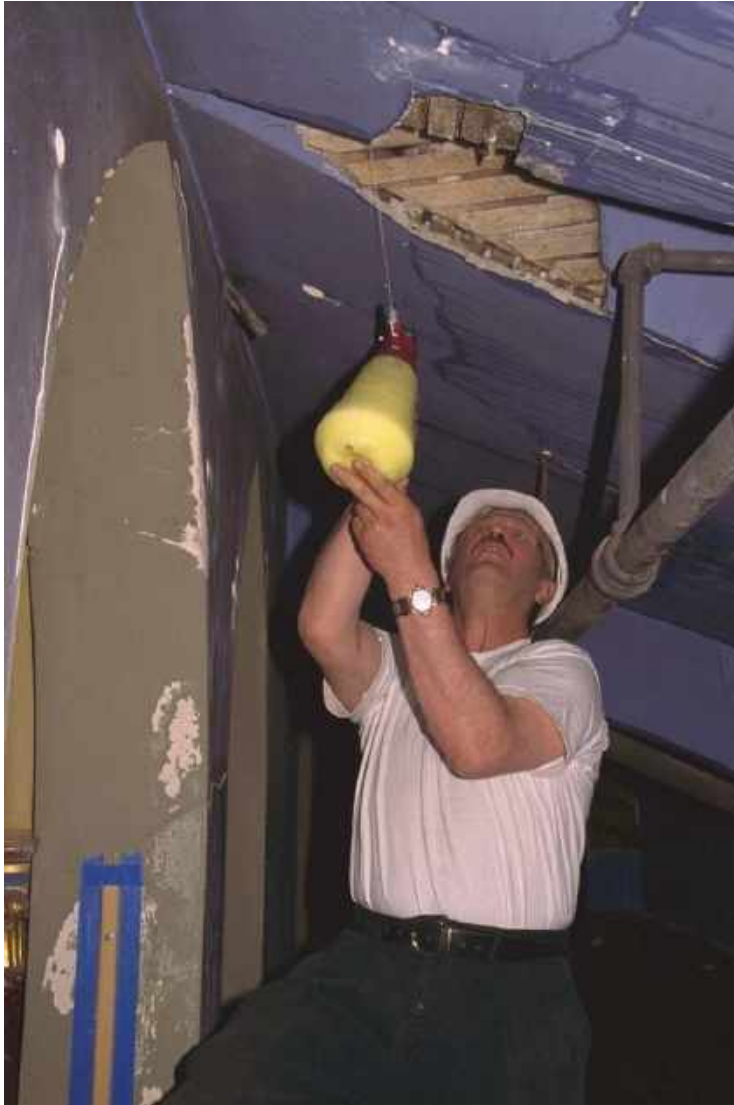
It was determined that some of the plaster elements had failed repeatedly in similar ways. Typical of this class was the element found as part of several column capitals to the spring line of the ceiling arch.

One particularly ornate element that caused concern was a double-headed branch form with a cross-sectional area of less than 1 square inch joining otherwise unsupported parts weighing over three pounds. Of the 26 examples, 14 had failed and broken at the narrowest point, dropping a dangerously heavy part to the floor 50 feet below.

Important from a safety perspective, the replica weighs less than three ounces. In the unlikely event that one of these elements should fail, no damage would occur.

Repairs to this element consisted of adding urethane sections where the original had dropped off. Full replicas were cast in urethane and then cannibalised to provide just the section required for the repair. Fracture lines in the original were cut smooth and the urethane repair part was cut to fit. Sections were attached to the original with Rhoplex-based adhesive and reinforced with fine bamboo dowels.

In this way, the original gilding of the subject element was preserved, with infill finishing required only on the urethane replacement portion. In some cases, entire plaster elements have fallen to the floor. In these cases, moulds were created from original existing samples, and replacement parts were cast in either plaster of Paris or urethane. Urethane was used in any case where the part would constitute a safety hazard if it failed.

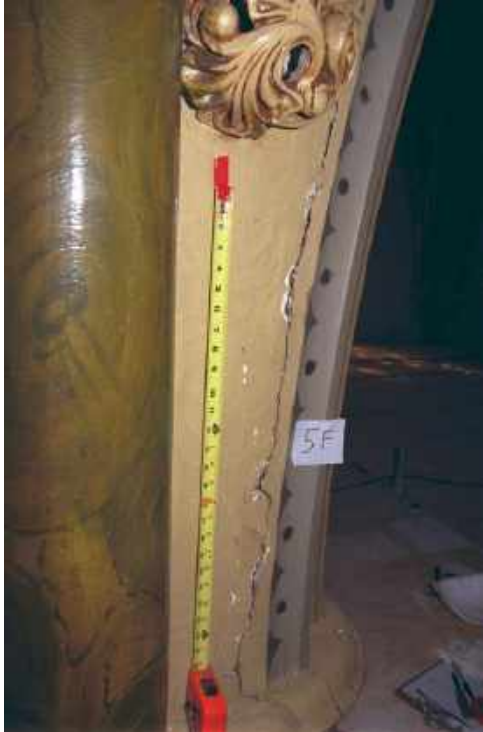
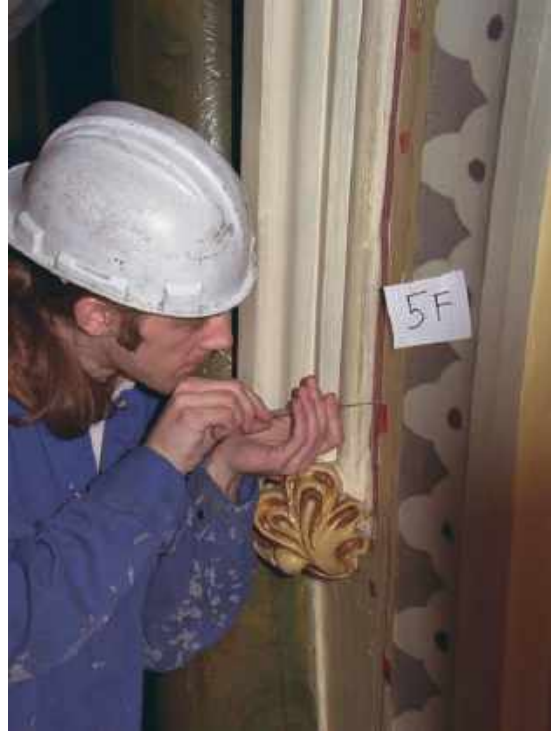
The protection of original plaster in the arcades was not considered as important as in other places even though it was in the worst condition of any plaster found in the project. More important was the consideration of minimising dust and debris that would have resulted from any conventional approach to repairing this plaster. Under normal construction site circumstances, most or all of this plaster would have been deemed worthless and shovelled off the walls and ceilings to be replaced with new plaster or drywall.

Access to the inner surface of plaster and lath was allowed by drilling through the surface.

The approach consisted of drilling 1 1/2" access holes through the plaster at intervals between the rafters along the highest point of the ceiling. This allowed for the insertion of a wand into the void above the

plaster from which a consolidant could be sprayed under moderate pressure.
