Marble Conservation at the Dominion Public Building, Hamilton, Ontario

Rod Stewart

Abstract

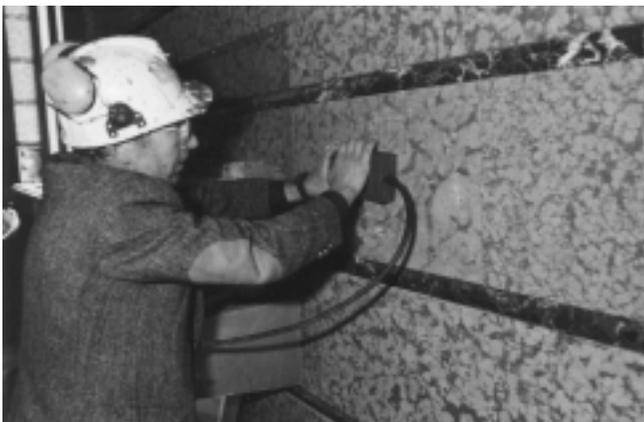
Figure 3. Technician passes 1-GHz antenna across the wall surface.

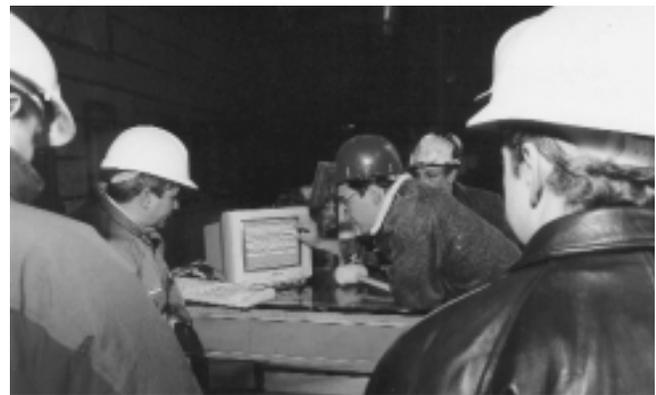
Figure 4. Data are collected and displayed on a monitor for interpretation. With practice, a technician can interpret the wave patterns.
